Electrocution – Inspection #1097559

A **26 year old male** employee was electrocuted after coming into contact with an energized lifting table. On the day of the accident, the victim was using an air hose and broom to clean a six inch work area between the Lauderdale-Hamilton brand gang rip saw and a lifting table. Shortly afterwards, the victim was found lying face down, and unresponsive, his body still in contact with the two machines. When an employee attempted to move the body to administer first aid, he was shocked. During the investigation it was determined, that the lifting table was equipped with a flexible power cord connected to a receptacle fixed to the frame of the gang rip saw. The grounding wire located inside the receptacle was covered in insulation, rendering it ineffective. In addition, the flexible power cord revealed seven areas of damage to the sheath, and insulation, including two complete breaks which were spliced together, and then covered by electrical tape. The energized inner copper wires of the flexible cord were in contact with the lifting table as a result of the cord being pinched by the frame of the lifting table during use. As the victim was attempt

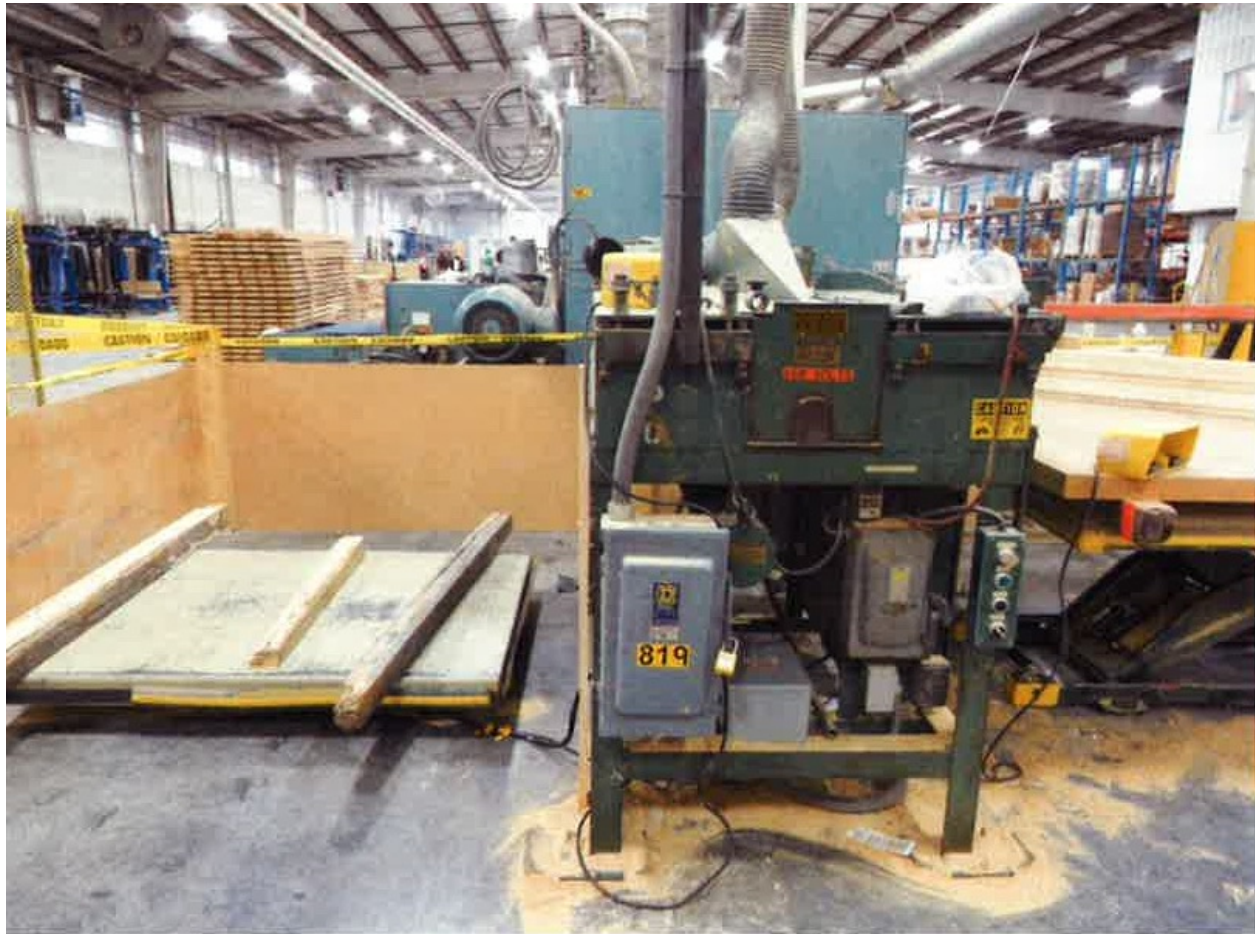
29 CFR 1910.304(g)(5)	The path to ground from circuits, equipment, and enclosures was not permanent, continuous, and effective: In that one employee, located in the production area, was exposed to electric shock when the 480 volt lifting table he was operating failed to maintain a permanent and continuous path to ground.
-----------------------	--

Photo 1 of 2 – Photo of the Lauderdale-Hamilton brand rip saw, and the lifting table located to the left of the saw.

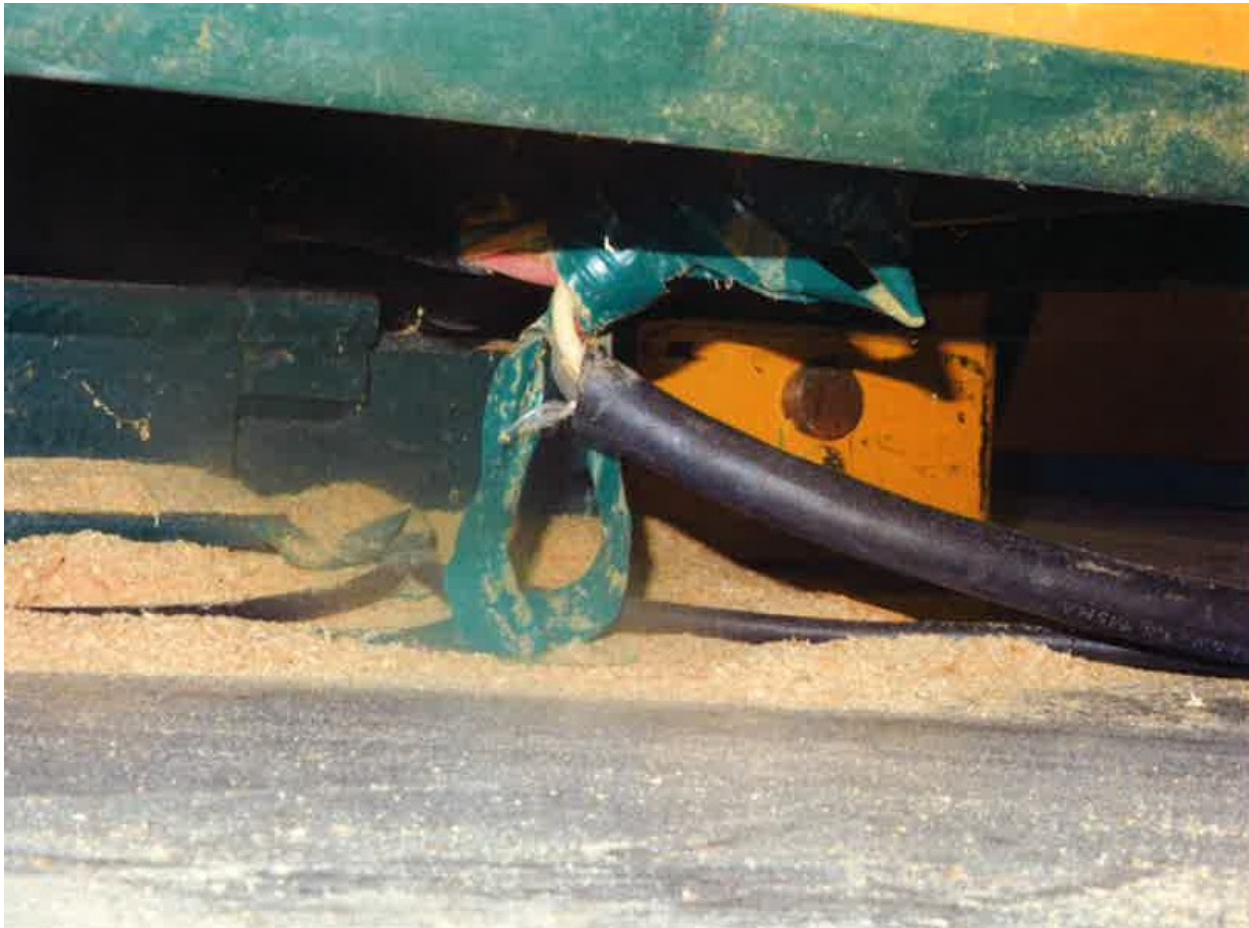
29 CFR 191.305(a)(2)(x)	Flexible cords and cables were not protected from accidental damage, as might be caused, for example, by sharp corners, projections, and doorways or other pinch points: In that one employee, located in the production area, was exposed to electric shock while using a lifting table. The flexible cord supplying power to the lifting table had 7 different areas of damage to the insulation due to it being pinched by the table when it would be lowered.
-------------------------	---

29 CFR 1910.305(g)(2)(ii)	Hard-service cord and junior hard-service cord No. 14 and larger were repaired by splicing, which did not retain the insulation, outer sheath properties, and usage characteristics of the cord that was spliced: Note: Hard service flexible cords No. 12 or larger may be spliced if the splice retains the insulation, outer sheath properties, and usage characteristics of the cord being spliced: In that one employee, located in the production area, was exposed to electric shock while using a lifting table that utilized a power cord that had two splices that were not properly insulated.
---------------------------	---

Photo 2 of 2 – Photo shows the power cord for the lifting table and one of the several splices to the cord.
