## **Electrocution – Inspection #1105744**

**Electrocution – Inspection #1105744**

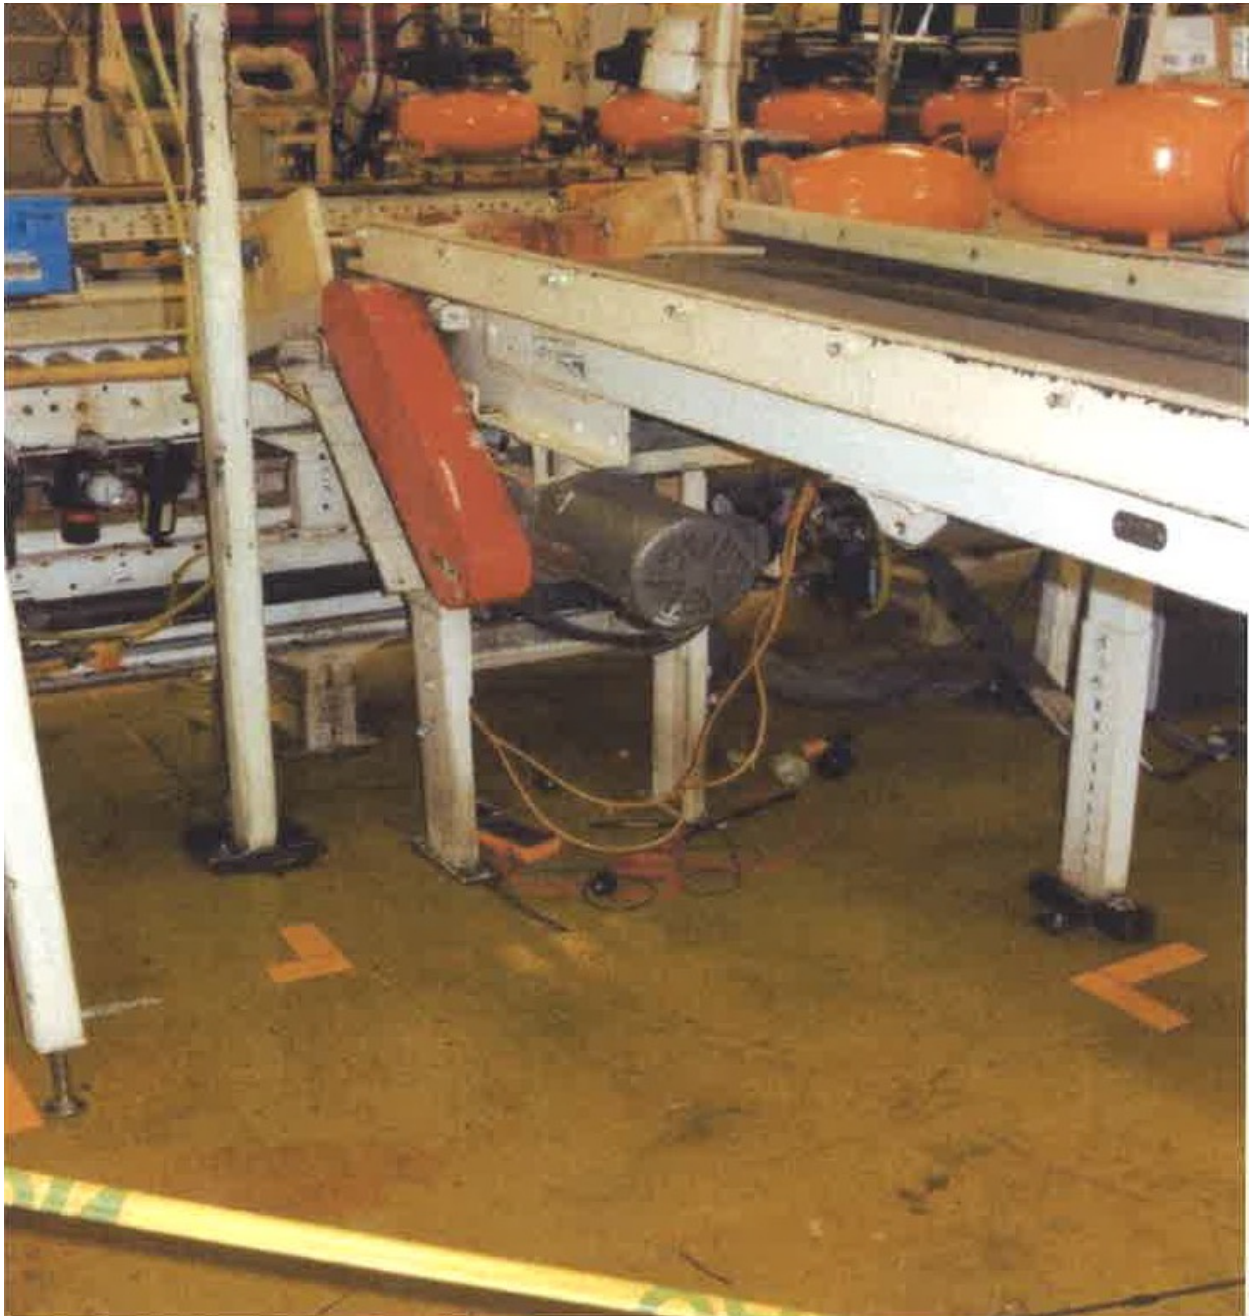
A **46 year old male** employee was fatally injured when he was electrocuted while troubleshooting a motor on a conveyor. The victim obtained a work order that the North Tank conveyor on assembly line #2 had stopped working. The North & South Tank assembly lines had been relocated from another employer and installed at this location approximately four years prior to the accident. This was the first time maintenance had worked on either conveyor motor since installation at this site. After obtaining the information from the group leader, the victim proceeded to crawl under the conveyor to troubleshoot the motor. A production employee subsequently noticed the victim was not moving. The victim was found under the conveyor, unresponsive, with blood on his cheek. First aid and CPR were administered immediately. It was determined during the investigation, that the victim utilized the cord and plug method for lock out tag out in attempt to de-energize the North Tank conveyor motor. The victim was unaware that the male end of the conveyor motor plug was still energized at 460 volts, and attached to the disconnect side in the “on” position. The North and South Tank assembly lines had been wired incorrectly during installation. The correct wiring method would have been the female end on the disconnect side, and the male end on the motor side. The victim was electrocuted when inadvertently touched the energized male end of the plug.

29 CFR 1910.303(b)(2)	Listed or labeled equipment was not installed and used in accordance with any instructions included in the listing and labeling. In that a) the power cord from the disconnect for the North Tank conveyor motor located at the yellow tank air compressor assembly line, was installed with the male plug end at the end of the cord, exposing the employee to 460 volts when the cord was unplugged; b) the power cord from the disconnect for the South tank conveyor motor located at the yellow tank air compressor assembly line, was installed with the male plug end at the end of the cord, exposing the employee to 460 volts when the cord was unplugged.
-----------------------	--

Photo 1 of 1 – Photo of the drive motor for the North Tank conveyor. The victim was found on the concrete directly below this motor. The multi meter and screwdriver were both left in the area from work taking place after the accident occurred.
