Fall from fixed ladder – Inspection #1058964

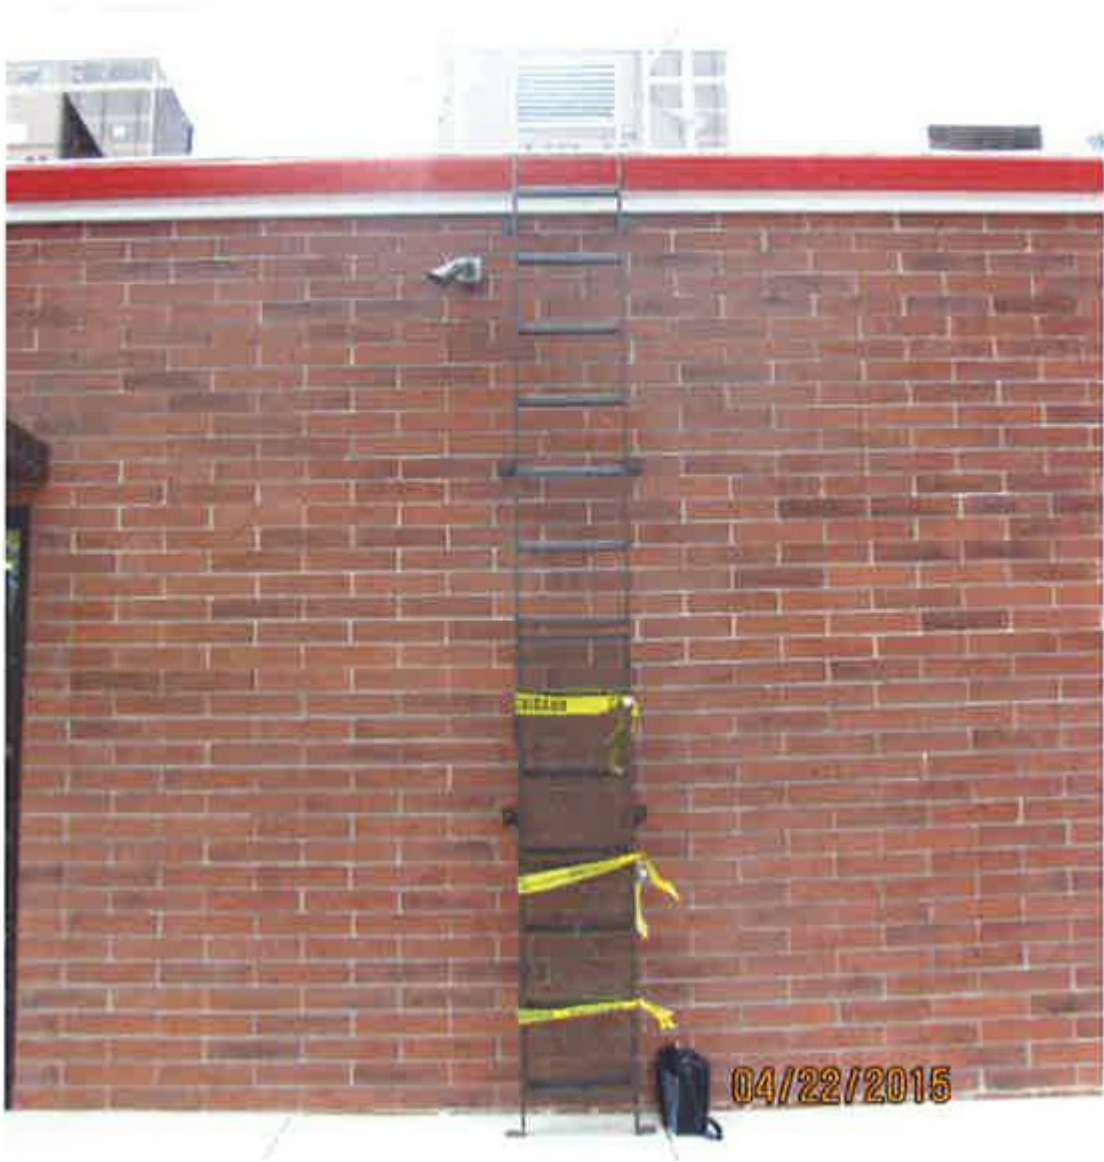
Photo 1 of 2 – This photo shows the fixed ladder bolted to the building for roof access.

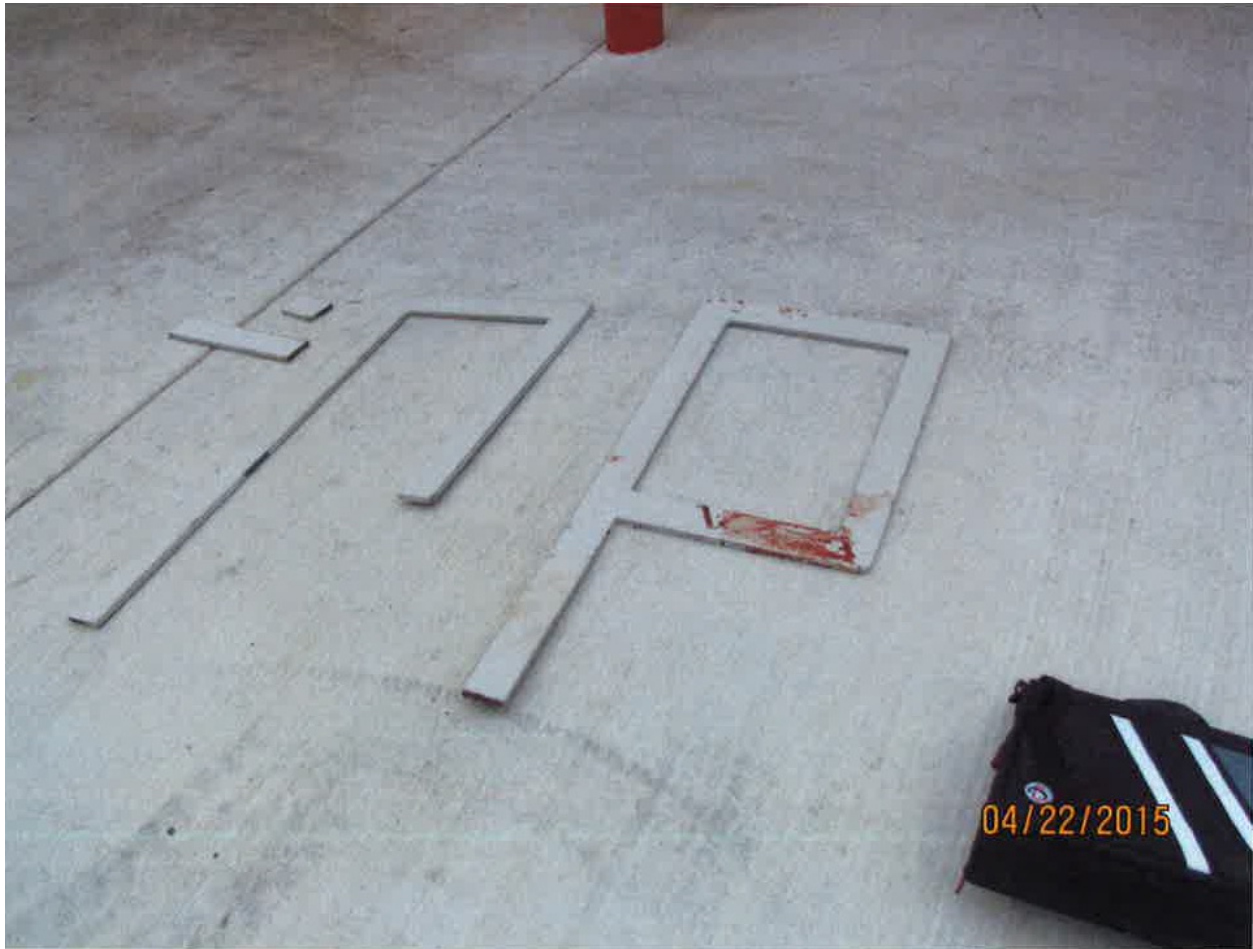
A **55 year old male employee** was fatally injured when he fell from a fixed ladder attached to the side of a convenience store. On the day of the incident, the victim climbed the fixed ladder with a box of HVAC filters to change the filters in the air units located on the roof of a convenience store. The ladder was constructed of flat iron bars and fabricated rungs. Once the victim reached the top of the ladder, the upper side grab rails broke free. The victim fell 14 feet to the sidewalk below. During the investigation, it was determined the ladder had been installed approximately one year prior to the accident. The ladder was maintained in a locked condition to prevent unauthorized access to the roof. The ladder possessed no damage or structural defects that would have been noted during a visual examination. A closer examination of the broken grab rails revealed minimal weld and evidence of rust on the bare metal surfaces that would have been touching one another. These conditions would not have been visible while the ladder was in place and whole with exterior paint covering the ladder. Video evidence revealed the filters carried by the victim were in a plastic bag and did not appear to be of a size or weight as to hamper his safe use of the ladder. It was determined that the victim would have been unable to determine any condition of the ladder and the extending side grab rails that would have rendered them unsafe prior to the accident occurring. No citations were issued since the hazards to the ladder would not have been detectable during normal inspection and use.

Photo 2 of 2 – This photo shows the upper grab rails of the ladder that broke free from the fixed building ladder.
