Fall from outdoor platform – Inspection #1071301

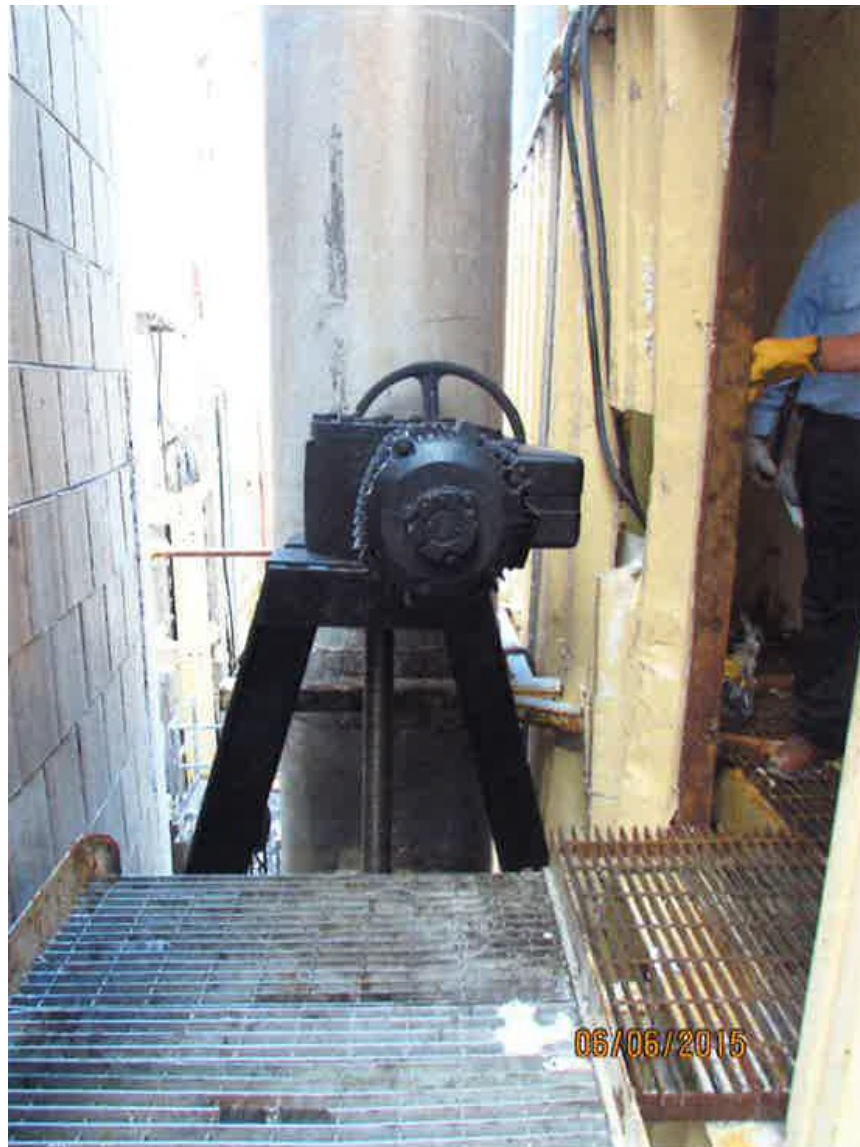
29 CFR 1910.23(a)(8)	Every floor hole into which persons can accidentally walk was not guarded: In that employees were working on a platform with multiple floor holes.
----------------------	--

29 CFR 1910.23(c)(1)	Open-sided floors and/or platforms four feet or more above adjacent floor or ground level were not guarded with standard railings (or equivalent) and toe boards: In that the outside upper platform of the 250 Trans Tower, located in the Kraft Mill, did not have a guardrail system installed to protect employees from a 40 foot fall hazard.
----------------------	--

Photo 1 of 2 – This photo shows the view of the valve and the unguarded holes between the platforms and building surfaces.

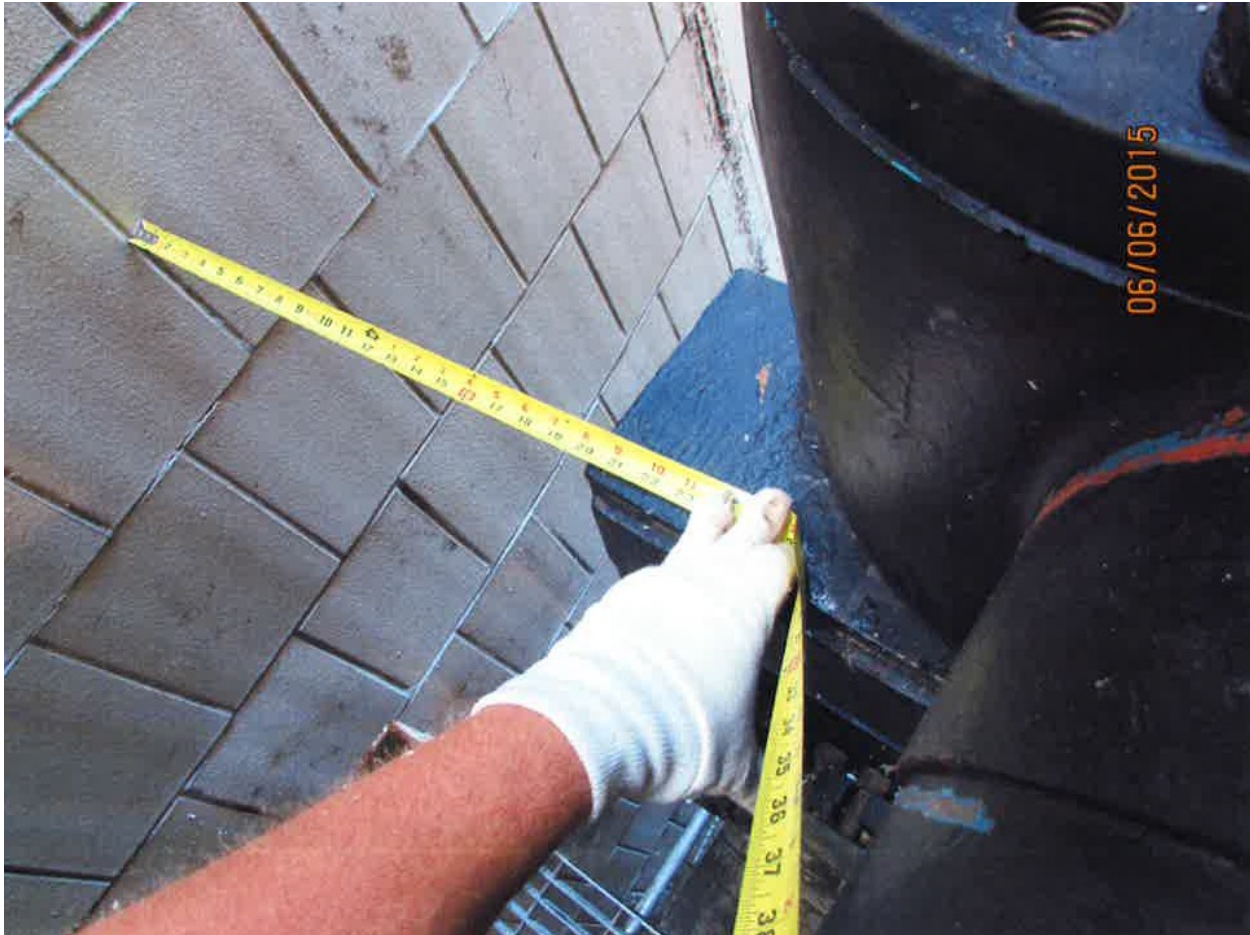
Photo 2 of 2 – This photo shows the view of the valve and the unguarded 20 inch hole between the valve and building wall.
