Struck by & crushed by hydraulic arm – Inspection #1094003

Citation(s) as Originally Issued

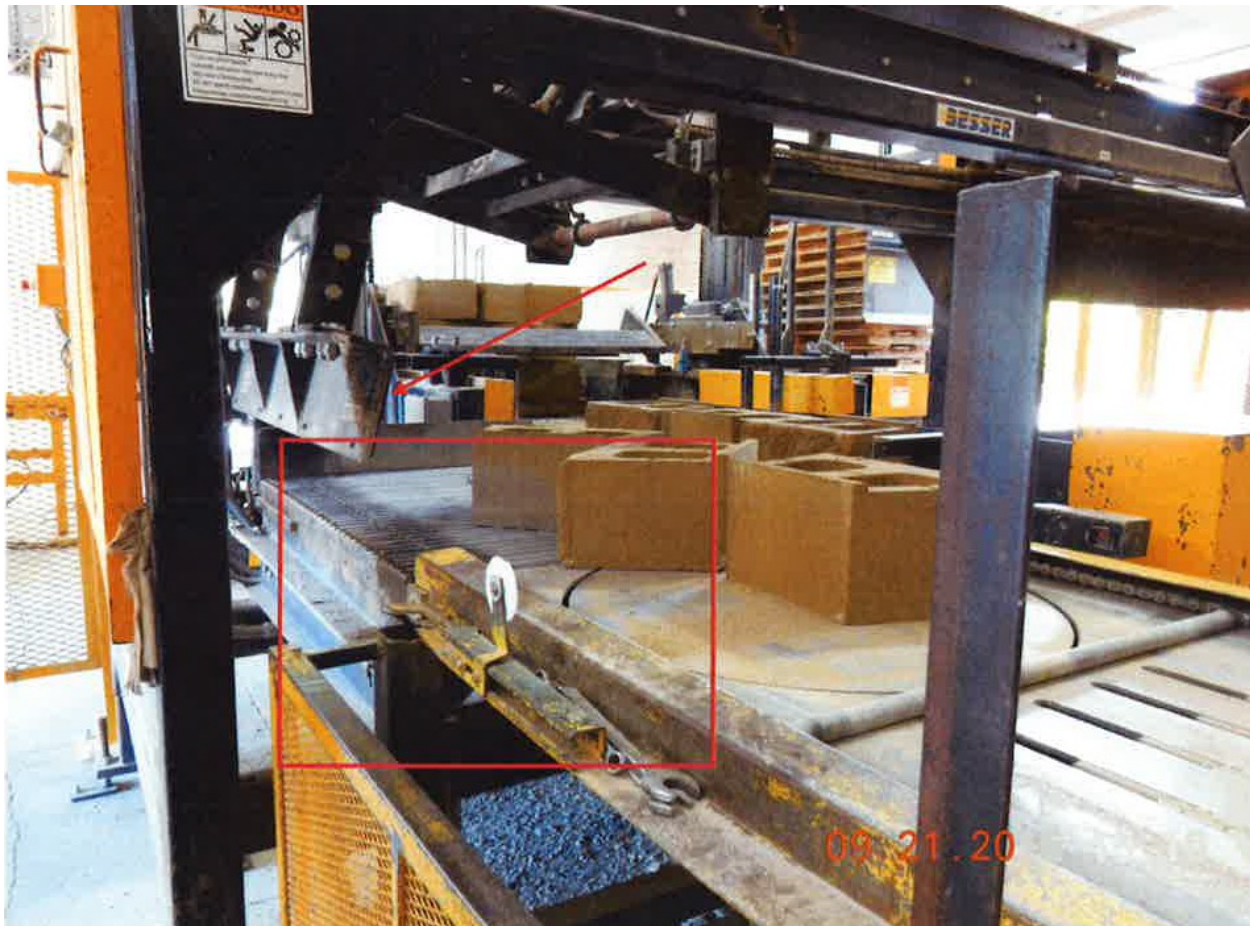
A **44 year old male** employee was crushed by a hydraulic arm of the overhead side feeder when he leaned into the Besser automatic block cubing, and packaging machine. The victim was working at the Besser automatic cubing machine using a push/pull bar approximately 40-inches long to straighten non-square landscaping retaining wall concrete blocks as they went into the overhead side feed area for packaging. Inside the overhead side feed area was a hydraulic arm that moves blocks onto the carriage plate. The carriage plate then moves the blocks into the machine to group the blocks for pallet packaging. Since there were no witnesses to the accident, it is possible the victim could have missed one of the blocks, and instead of using the push/pull bar, he leaned from the waist into the machine to try, and quickly adjust the block without shutting the machine off. The victim leaned into the path of the hydraulic arm, and was crushed by it as it came down to push the blocks into the carriage plate. The pushing blade on the hydraulic arm was measured to be approximately 8-inches in height and 48-inches wide. The victim was fatality injured with crushing injuries to his upper torso. The investigation determined there was not a guard in place to prevent the employee from being able to access, or lean over into the overhead side feed area of the Besser automatic block cubing, and packaging machine.

29 CFR 1910.212(a)(1)	One or more methods of machine guarding was not provided to protect the operator and other employees in the machine area from hazards such as those created by point of operation, ingoing nip points, rotating parts, flying chips and sparks. In that they employer did not provide adequate guarding to protect employees from leaning or reaching into the Besser Automatic Cuber machine. An employee working at this machine was fatally injured after begin crushed by the hydraulic arm inside the overhead side feed area.
-----------------------	---

Photo 1 of 1 – The photo shows the overhead side feed area where the victim was found (red square) crushed by the hydraulic arm (red arrow).
