## **26 Explosion – Inspection #1184467**

A **43 year old male** employee was fatally injured during an explosion. On the day of the accident, the victim, a trailer mechanic, was working alone repairing a trailer in the maintenance shop of a freight distribution facility. There were no witnesses to the incident, and the building was deemed structurally unsound following the explosion. Through a detailed investigation, and incorporating findings from the Fire Marshall's Report, it was determined that a 55 gallon drum of Diesel Anti-Gel, a Category 2 Flammable liquid (flashpoint below 100°F or 3.78°C), was most likely involved in the explosion. The Fire Marshalls Report determined that there were vapors from the Diesel Anti-Gel present on the floor in front of the drum and in the drum itself. The valve handle on the drum may have become unknowingly opened as employees moved through the often travelled area. Possible ignition sources in the area included static shock and an electrical arc resulting from use of a nearby dropped electrical cord. Citations issued included, excessive quantities of flammable liquids being stored, containers of flammable liquids not covered, flammable liqu

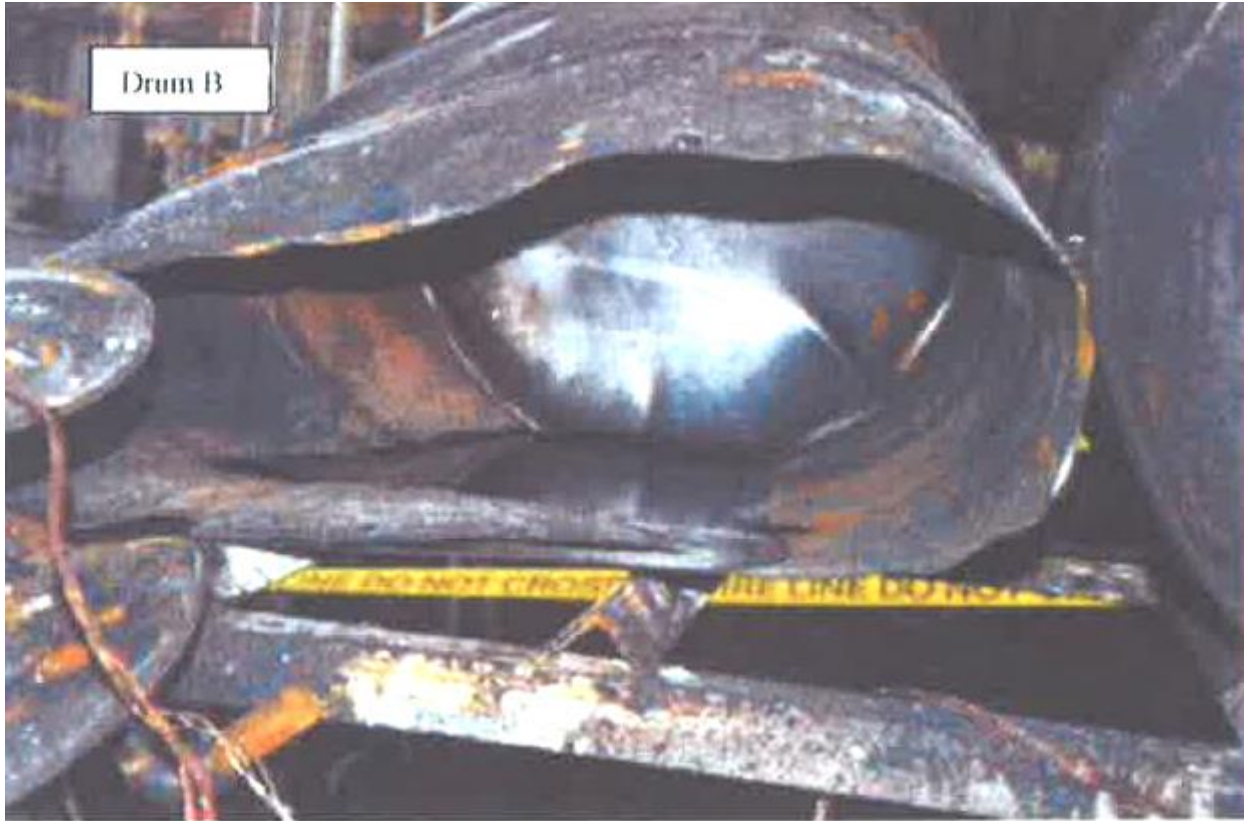
29 CFR 1910.106(e)(2)(iv)(a)	Category 1 or 2 flammable liquids, or category 3 flammable liquids with a flashpoint below 100F (3.78C) were not kept in covered containers when not actually in use. In that the 55 gallon drum of Penray Winter Pow-r Plus Diesel Anti-Gel located near the center of the Maintenance Shop had a 4 mm hole in the drum lid.
------------------------------	---

29 CFR 1910.106(e)(6)(i)	Adequate precautions were not taken to prevent the ignition of flammable vapors. In that the Penray Winter Pow-r Plus Diesel Anti-Gel vapors ignited causing an explosion in the Maintenance Shop while an employee was repairing a tail light on the trailer.
--------------------------	--

Photo 1 of 1 – Drum B, Category 2 flammable liquid, determined by the Knox County Fire Marshall to be the fuel source of the initial explosion.
