6 Crushed between bucket & rear of dozer – Inspection #1133990

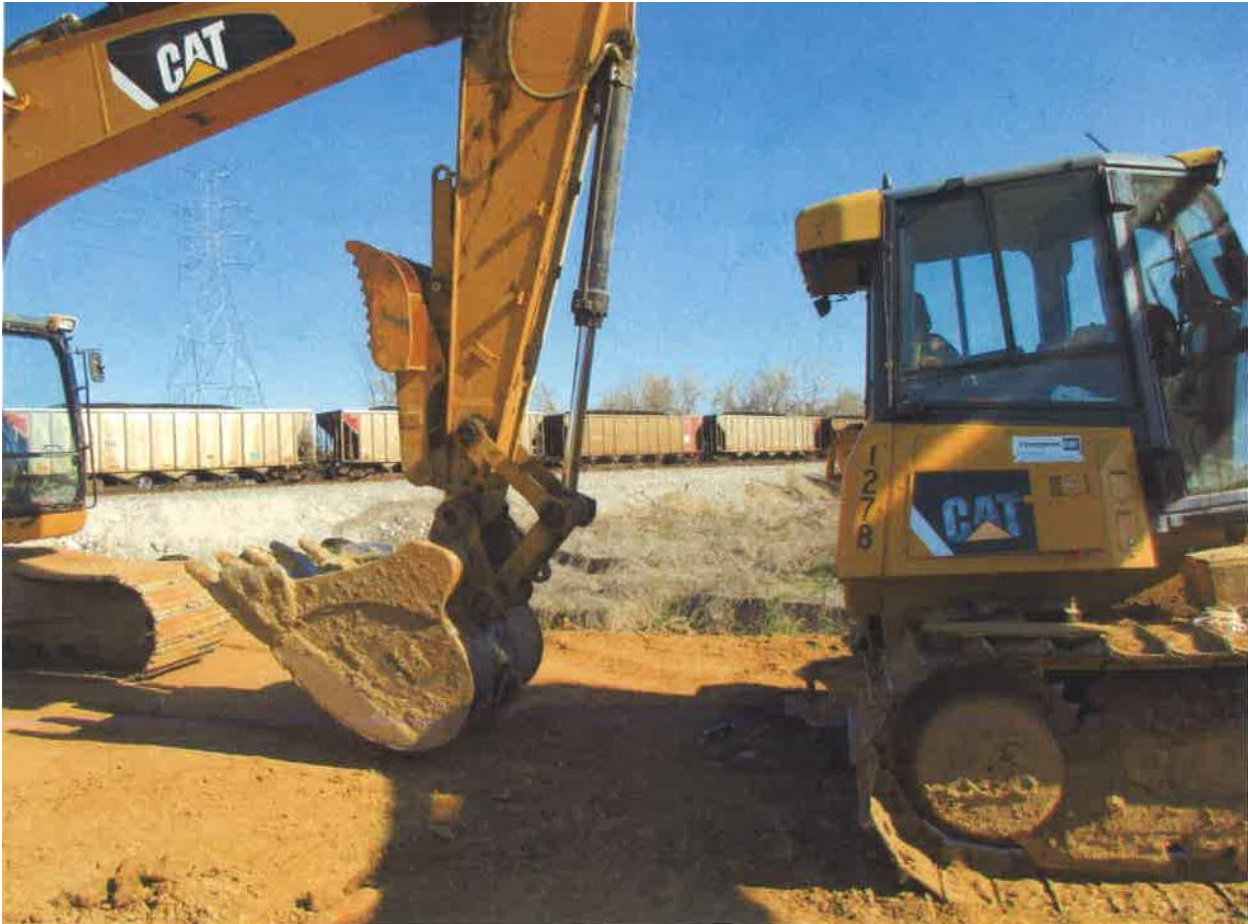
A **45 year old male** employee was fatally injured when he was crushed between the bucket of an excavator and the rear of a dozer. On the day of the accident the victim, a mechanic, and a second mechanic were trouble shooting a hydraulic leak on a dozer. In an effort to reach the belly pan of the dozer and repair the hydraulic leak, the front of the dozer was lifted with a wire rope sling and the bucket of an excavator and timber blocking was placed under the front of the dozer. Still unable to reach the belly pan, the mechanics decided to lift up the rear of the dozer. They began to repeat the process, using the excavator bucket with a wire rope sling to lift the rear of the dozer while the victim placed timbers under the dozer. The second mechanic operating the excavator reached over the left hand joystick controller to roll down the front window so he could hear the victim's directions as he was positioning the wire rope sling at the rear of the dozer. The engine was running on the excavator, and the mechanic's jacket, pocket or sleeve hit the joystick moving the bucket forward pinning the victim between the excavator bucket and the back of the dozer. During the investigation it was determined that the second mechanic did not place the hydraulic activation control level in the "locked" position prior to opening the front sliding window, as per the operation and maintenance manual of the excavator.

Photo 1 of 1 – View of the bucket of the excavator and the dozer. The victim was crushed between the bucket and the rear of the dozer.

TCA 50-3-105(1)	<p>Each employer did not furnish to each of its employees conditions of employment and a place of employment free from recognized hazards that are causing or are likely to cause death or serious injury or harm to its employees in that employees were exposed to:</p> <p>In that an employee was crushed between the bucket of a Caterpillar 325DL tracked excavator, and the rear of the Caterpillar D6K LGP dozer, while in the process of getting the wire rope sling ready to lift the rear of the dozer to insert wood timbers underneath increasing the ground clearance for repair work. Feasible abatement methods, among other, could be to:</p> <ol style="list-style-type: none">a) Require equipment operator to place the hydraulic activation control lever in the "locked" position in order to render all of the hydraulic controls inoperable prior to opening any of the cab's windows, as per the operation and maintenance manual;b) Train employees to stay out from between pieces of equipment while their engines were running;c) Train employees to communicate with each other and equipment operators when passing between or working on pieces of equipment; andd) Require equipment's engines to be shut off before employees can pass ow work between them.
