#8 Struck by load of Lumber - Inspection #1223664

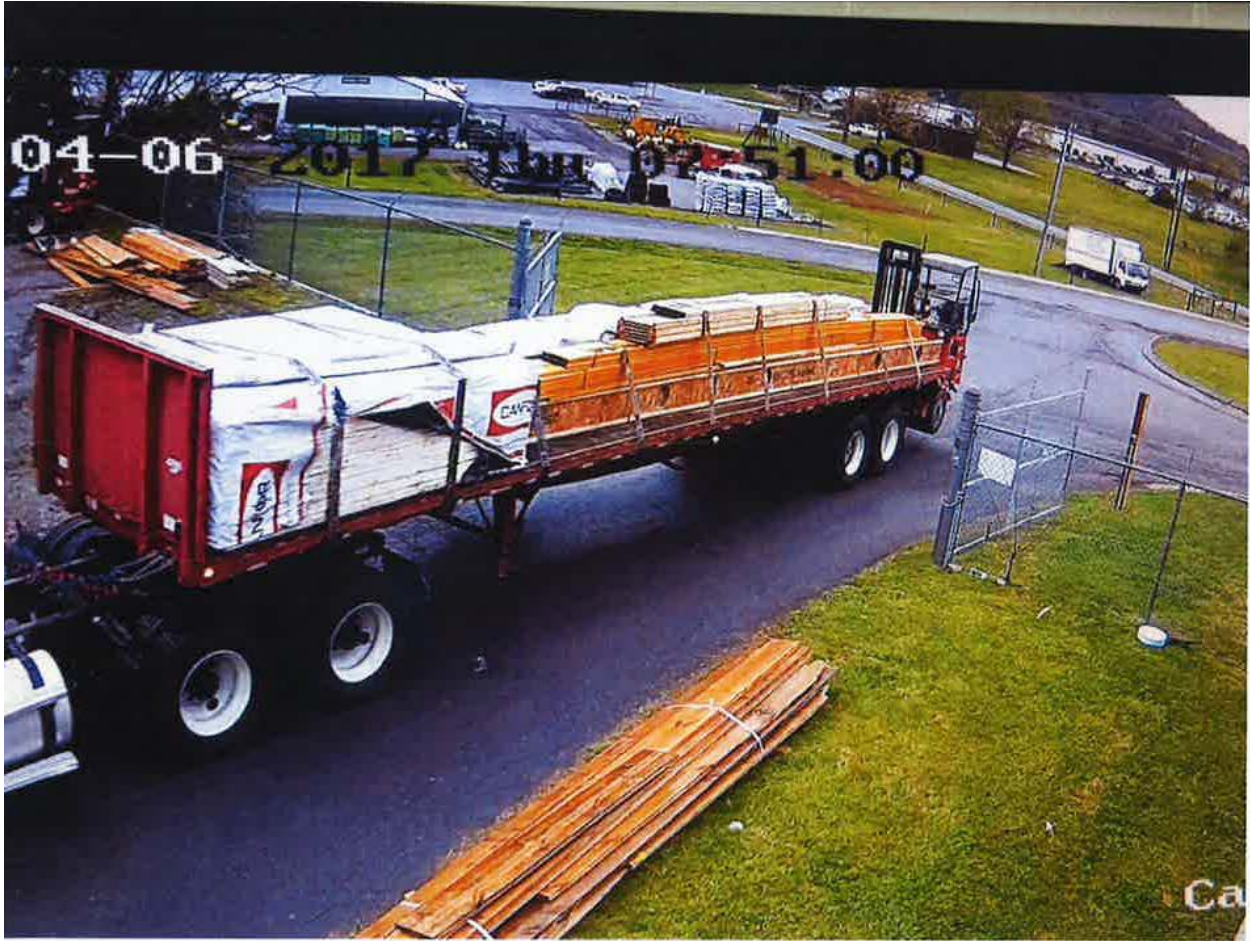
Photo 1 of 2 – The truck when it entered the yard for unloading.

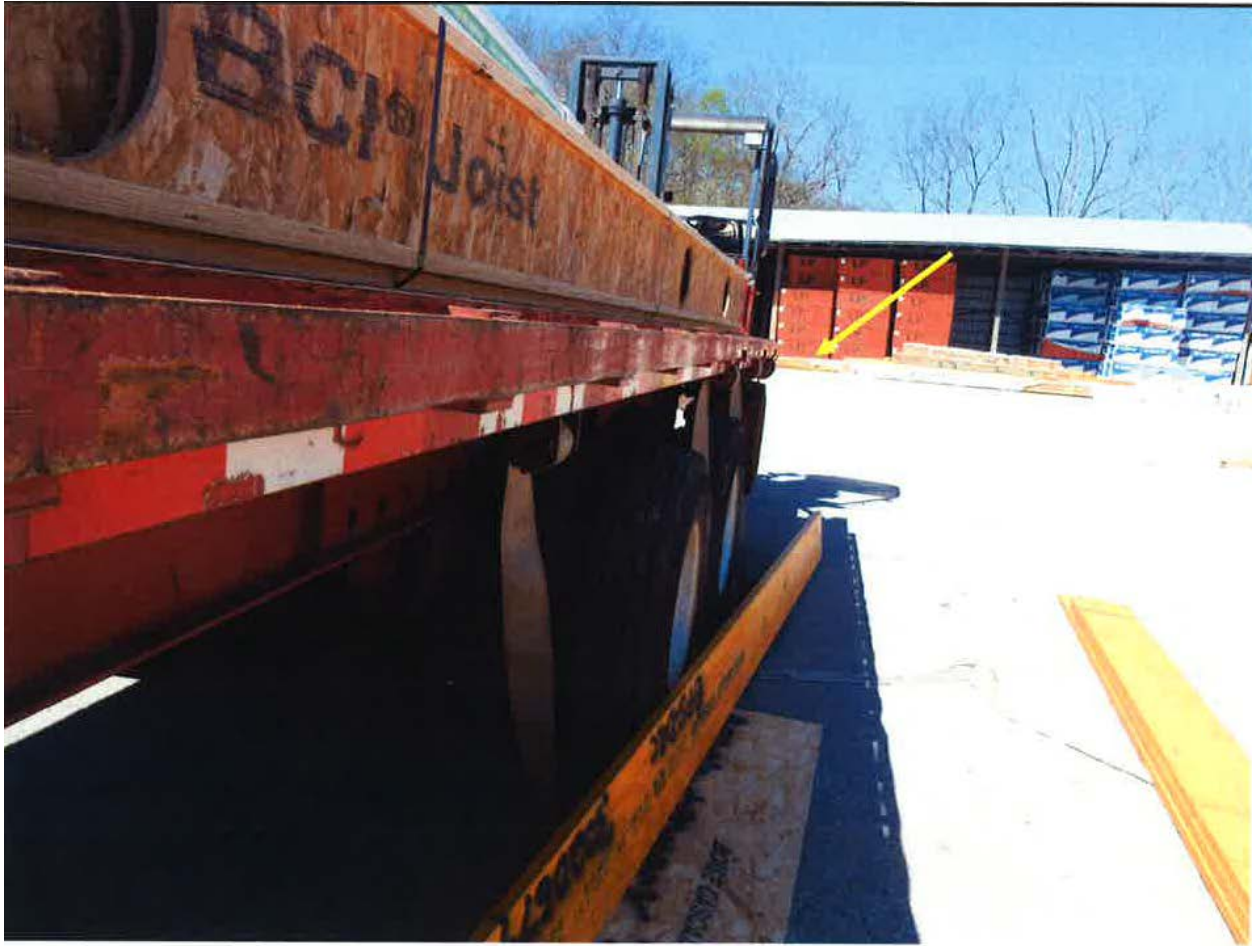
A **59 year old male** employee was fatally injured when he was struck by a load of lumber that fell from a trailer. On the day of the incident, the victim, a truck driver, arrived at the lumber yard with a load of lumber and building supplies. A company verbal rule stated that the truck driver is to unstrap the load and then vacate the area while the forklift operator unloads the trailer. The victim parked his truck, unstrapped the load, and entered the office to wait for the trailer to be unloaded. The forklift operator walked around the truck and trailer to verify the condition of the load and to ensure the driver had vacated the area. The forklift operator began unloading the trailer. As the forklift operator was attempting to remove the second load of lumber, the remainder of the load on the trailer shifted causing four bundles of lumber to fall off the opposite side of the trailer. The forklift operator immediately heard a scream, looked under the trailer, and found the victim had been struck by the falling load. The victim apparently left the office at some point during the unloading of the trailer, walked out to the truck, and began winding up the trailer straps. There was no hazard control method to ensure that the truck drivers remain out of the area during the unloading of the trailers.

Photo 2 of 2 – The yellow arrow indicates where the bundle of lumber struck the victim.

TCA 50-3-105(1)	<p>Each employer did not furnish to each of its employees conditions of employment and a place of employment free from recognized hazards that are causing or are likely to cause death or serious injury or harm to its employees.</p> <p>An employee was exposed to a struck by hazard as the employer had not established procedures to positively keep truck drivers out of the unloading area when their trucks were being unloaded. Among other methods, one feasible and acceptable abatement method to correct this hazard would be to develop a system where the truck driver relinquishes his truck to the forklift operator for unloading and then stays in a designated area away from the truck until unloading is completed.</p>
-----------------	---
