21 Fall from elevation---Inspection #1311108 Mid South Specialities

A **49 year old male** was fatally injured when he was **fell 15'** to a concrete floor from the roof of a “safe room” inside the warehouse section of a new building. The victim was painting the cage of the fixed ladder that led from the flat roof of the safe room to the roof access. He was using a paint roller that was attached to an extension pole. He was not wearing any type of personal fall arrest system while he was painting the cage. In addition, the edge of the flat roof was not equipped with any other guardrail systems.

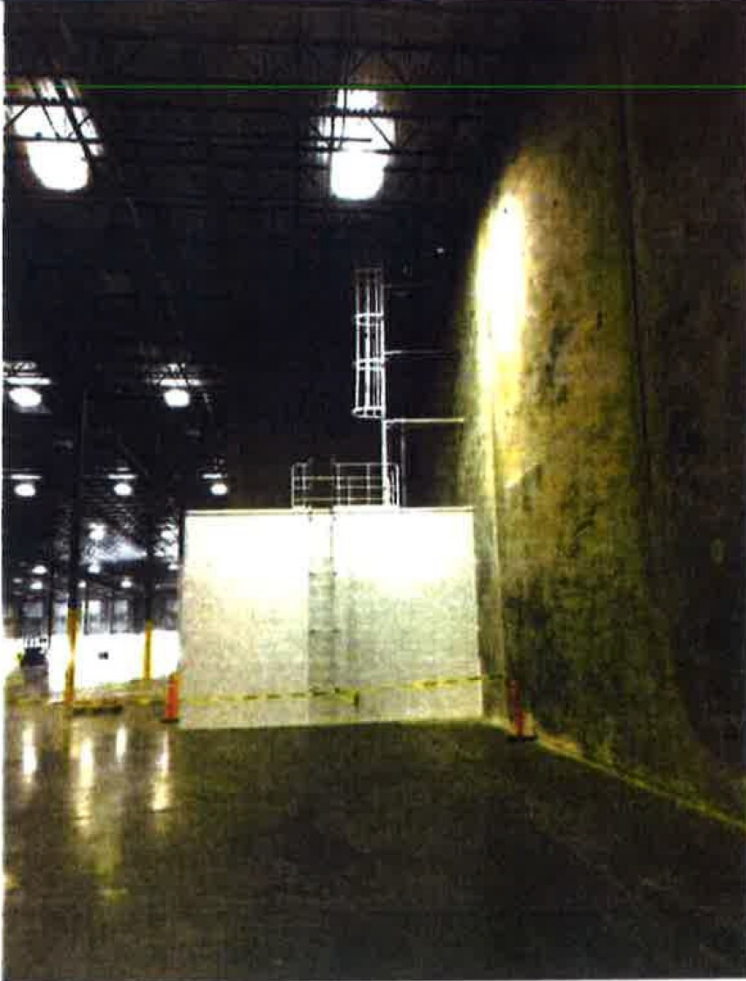
View of the west wall of the safe room in the warehouse showing the fixed ladder access from the floor of the warehouse to the top of the flat roof of the safe room, the caged fixed ladder access to the roof of the warehouse from the flat roof of the safe room and the guardrail system around the fixed ladder landings on the flat roof

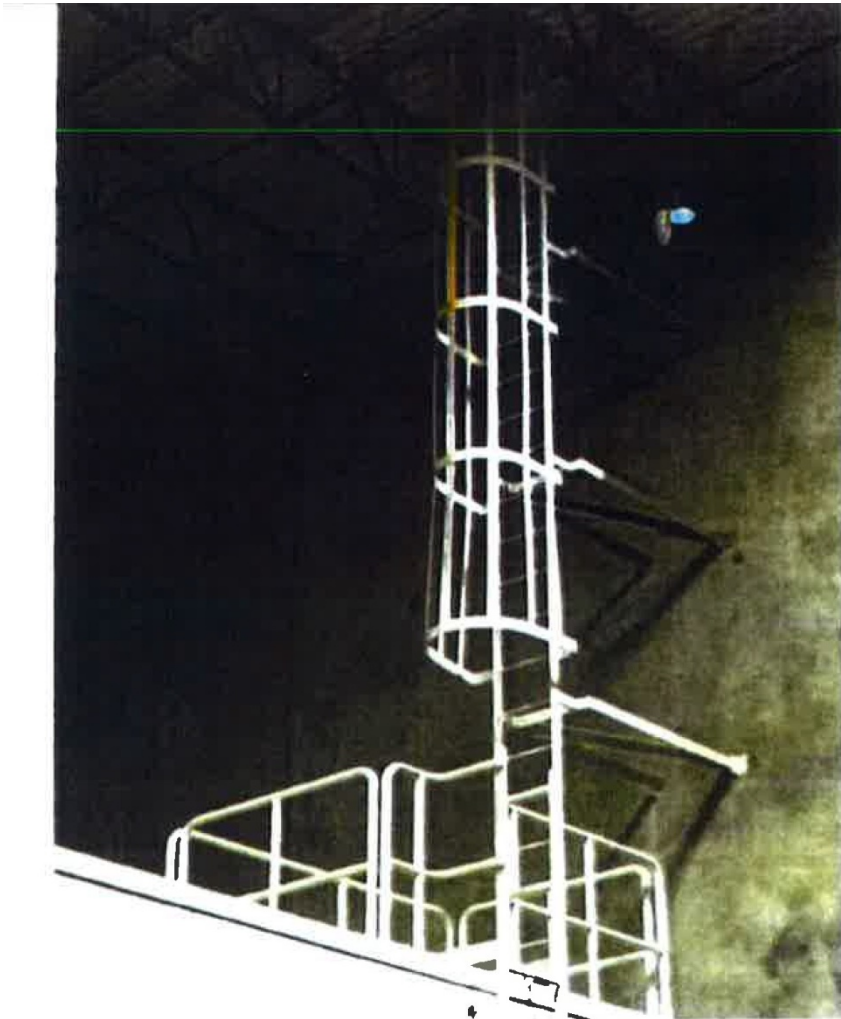
View of the caged fixed ladder access to the roof of the warehouse from the flat roof of the safe room and the guardrail system around the fixed ladder landings on the flat roof. The tops of the east and nor sides of the cage have a coat of yellow paint.

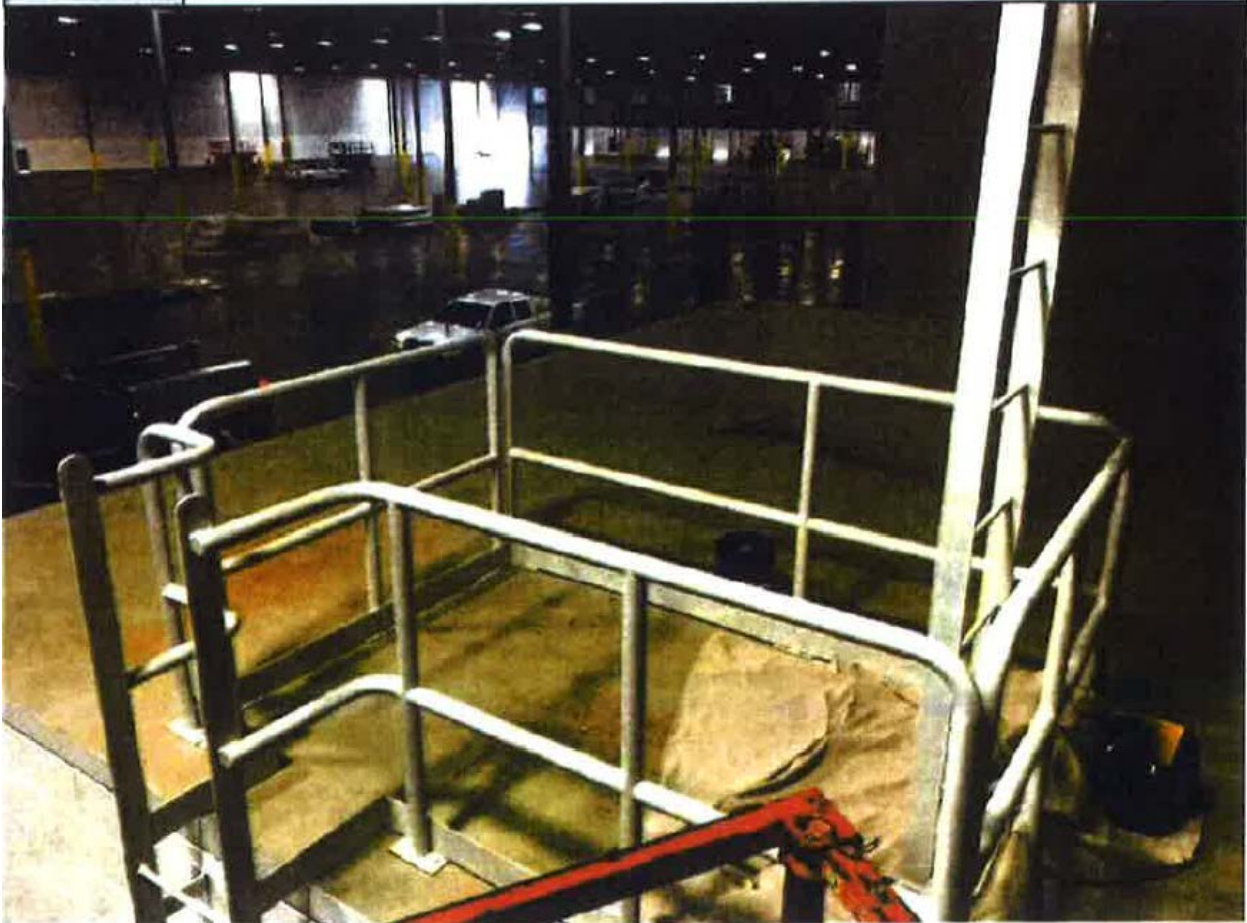
View from the platform of an aerial lift at the flat roof level showing the top of the fixed ladder access from the floor of the warehouse to the top of the flat roof of the safe room, the bottom of the caged fixed ladder access to the roof of the warehouse, the guardrail system around the fixed ladder landings on the flat roof and the buckets of yellow paint and the drop cloth.
