25 fall from elevation---Inspection #1316851 Just Hayes Construction

A **55 year old male** was fatally injured when he **fell** approximately 35' from a platform on a JLG all terrain fork lift while attempting to take photos of the framing job on a chimney located at a construction site for a residential home/hunting lodge.

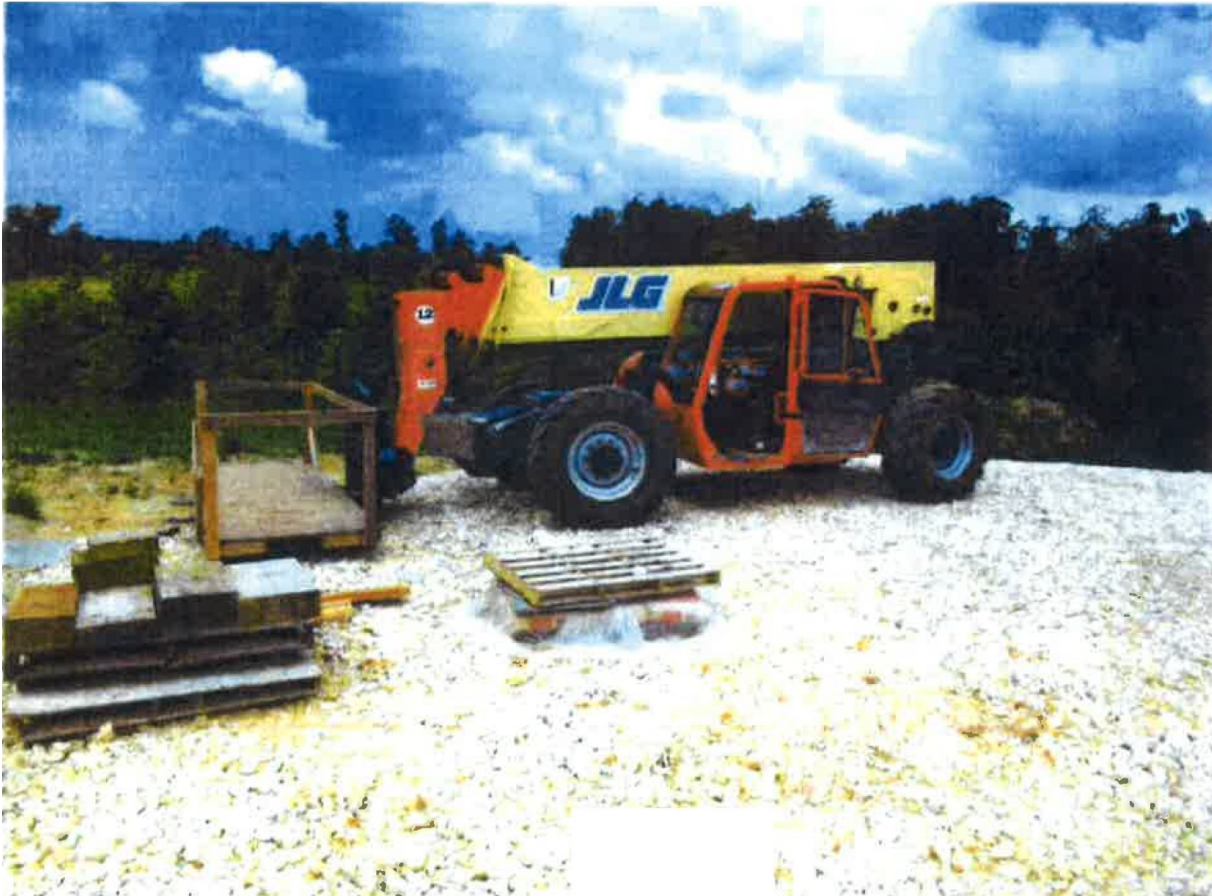
In that on May 17, 2018, the JLG telehandler model# GI 2-055A was being used to lift personnel on a job made platform that did not meet the manufacturers' design requirement, such as but not limited to, a complete guardrail system.

In that the wooden job made platform being used at the construction site to elevate employees was not equipped with a complete guard rail system on all sides resulting in an employee falling from the platform on May 17, 2018, suffering fatal injuries. The platform was not equipped with:

- a) guardrail system on the front open side
- b) midrail on the left, right and back side

The JLG telehandler model# G 12-055 A, serial# 0 160032190 shown below with the wooden job made platform attached to its forks with a rated strap was being used at the site to raise employees to allow them to work at elevated heights. This JLG and platform was being used when an employee was fatally injured at the worksite on May, 17, 2018 w1en he fell from the platform. The platform did not meet all criteria to be considered a JLG approved personnel work platform.

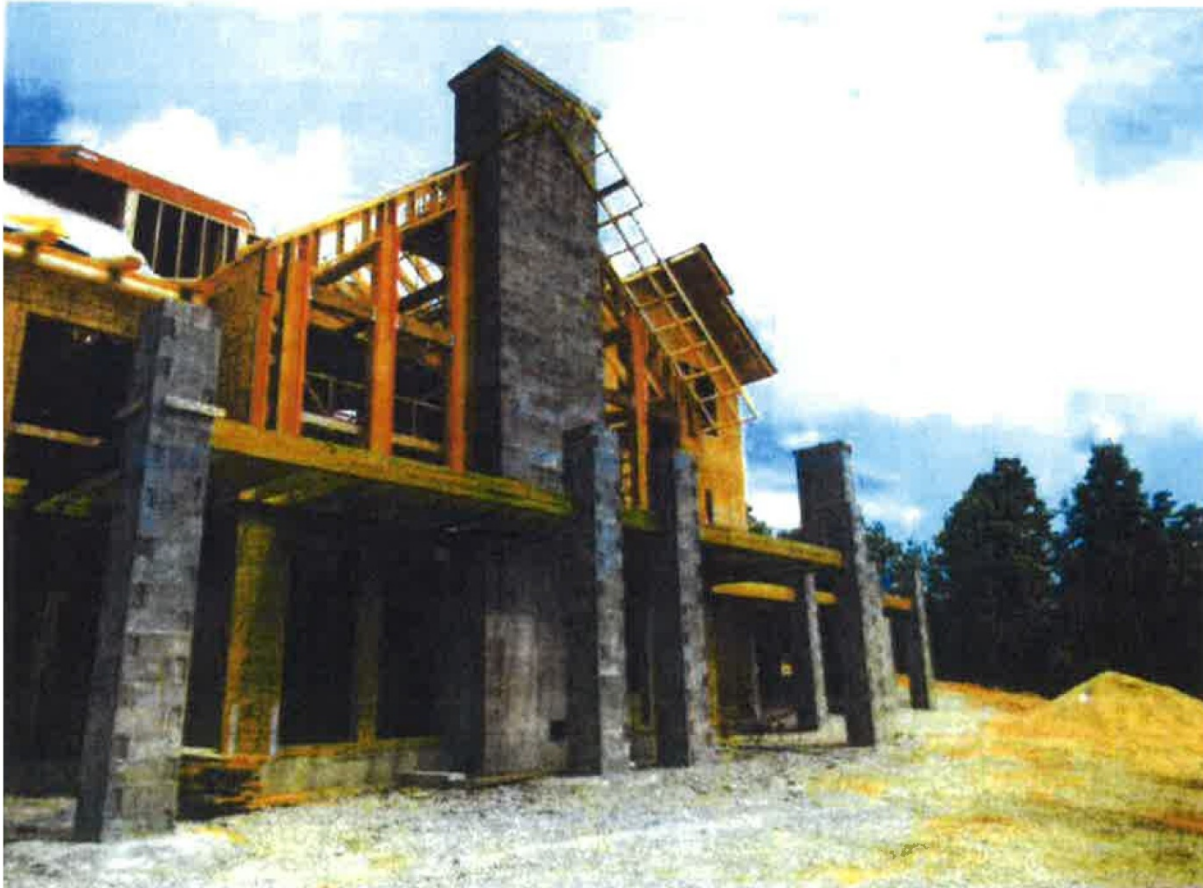
This photo shows the area where the JLG was positioned at the time of the incident. The fatally injured employee was standing in the wooden job made platform, elevated by the JLG telehandler, near the chimney shown below, at the time of the incident. The employee was attempting to take photos of the framing in the area of the chimney when the incident occurred. The on site contractor stated the deck floor was 12 feet above ground level and the chimney was 26 feet above the floor of the deck. The estimated fall distance was approximately 35 feet.
