38 Fall—inspection 1353093 Davco Roofing & Sheet Metal

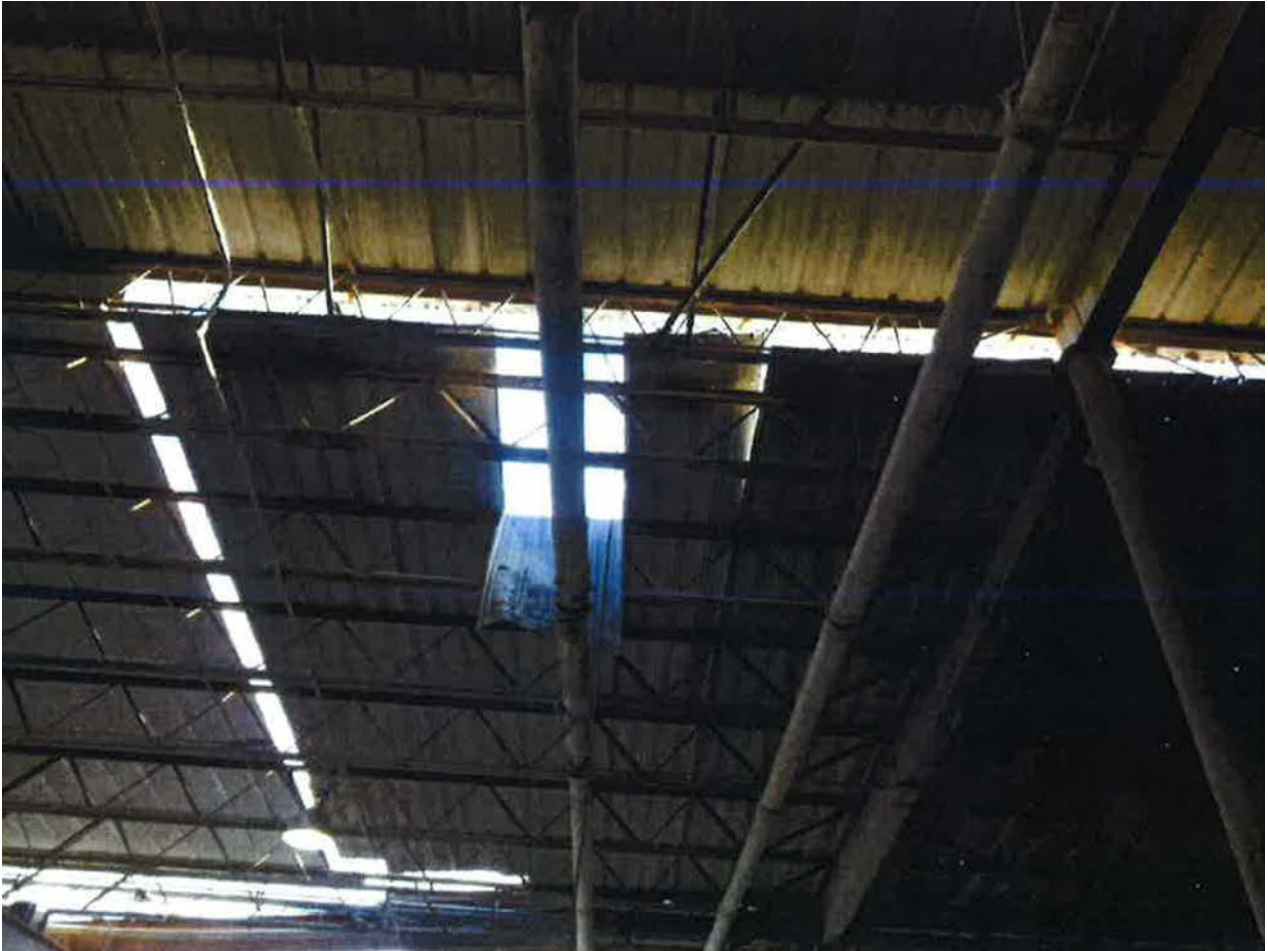
A 36 year old male was fatally injured when he fell 23' to the concrete while in the process of removing old sheet metal roofing to install new roofing. The existing roofing was constructed with metal in sheets measuring 3' X 30'. The metal was attached to bar joists and Z purlins with sheet metal screw fasteners. The victim was a foreman for one of the crews on site.

In that two employees were allowed to work on a surface whose structural integrity had been compromised by the removal of fasteners.

Picture shows the old roofing system and the area where the victim fell through. The fasteners had been removed from the roofing metal to facilitate the installation of the new eave.

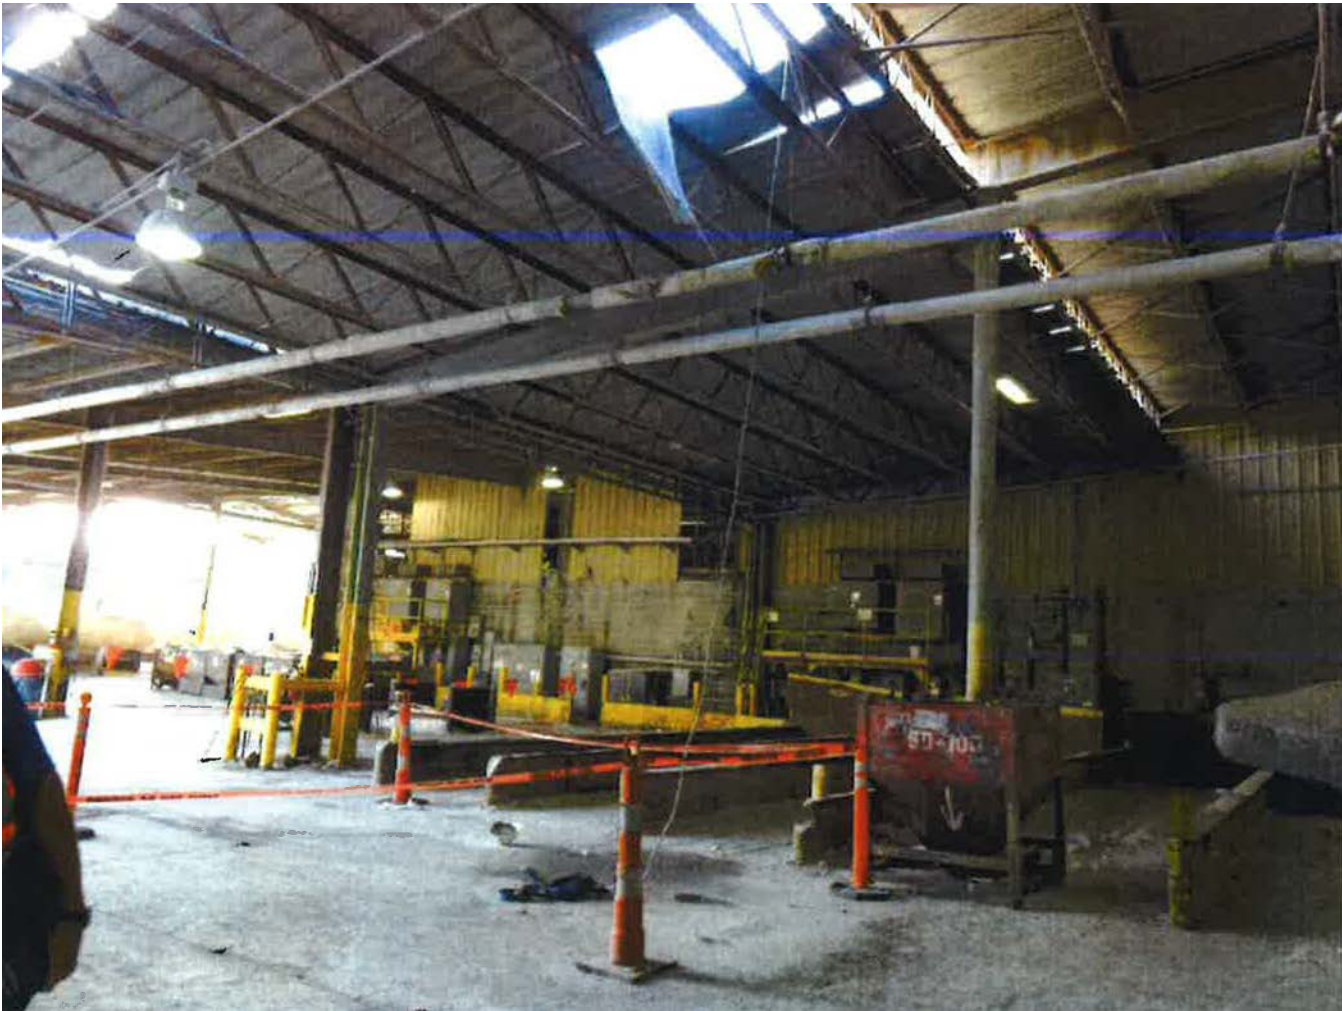
The employees were wearing fall protection harnesses and lanyards with a rope-grab attached to a vertical rope lifeline. The lifelines were anchored to one of the bar joists supporting the roof. It was determined that the victim had been working 30 feet from the anchor point of his lifeline, and his lanyard was adjusted accordingly. He then returned to a point near the lifeline anchorage to presumably retrieve his tools. It was at that point he stepped thru a piece of existing roofing material of which the fasteners had been removed, causing him to fall to the concrete. It appears that there was too much slack in the lifeline. When interviewed, employees stated that everyone had been adjusting the lanyard and lifeline combination as needed as they moved about the existing roof.

Instance A: In that two rope lifelines being utilized by two employees were in contact with the edge of metal roofing material and not protected against being cut or abraded (1926.502(d)(11)).

Instance B: In that two employees were utilizing personal fall arrest systems where free fall exceeded 6 feet (1926.502(d)(16)(iii)).

Photo shows the harness, lanyard, and lifeline that was worn by the victim.
