1 Crushed by paper wind-up machine – Inspection #1370482

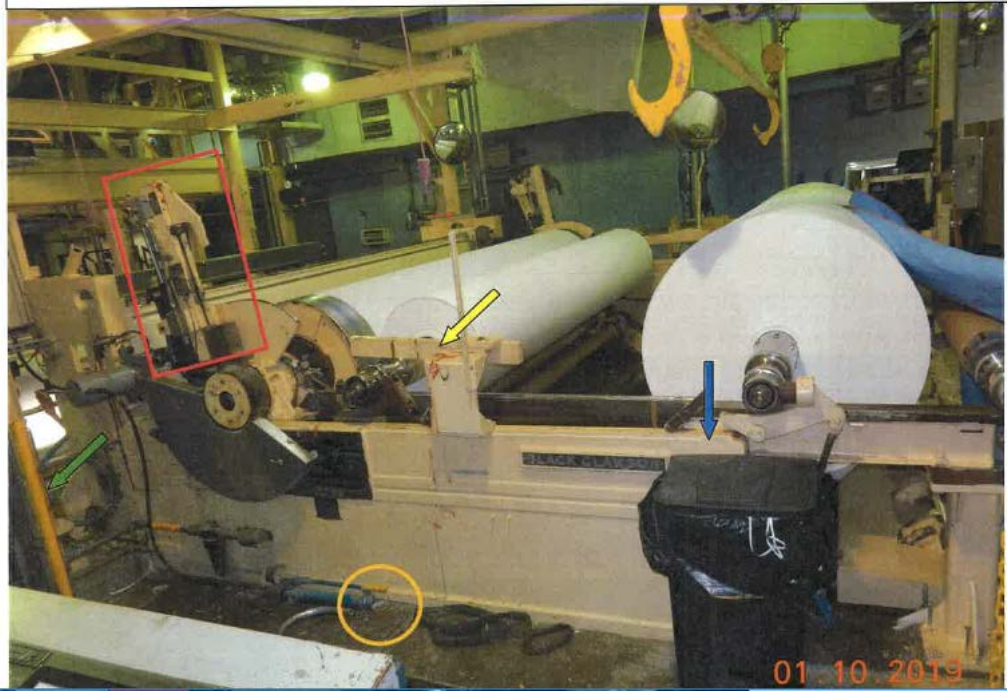
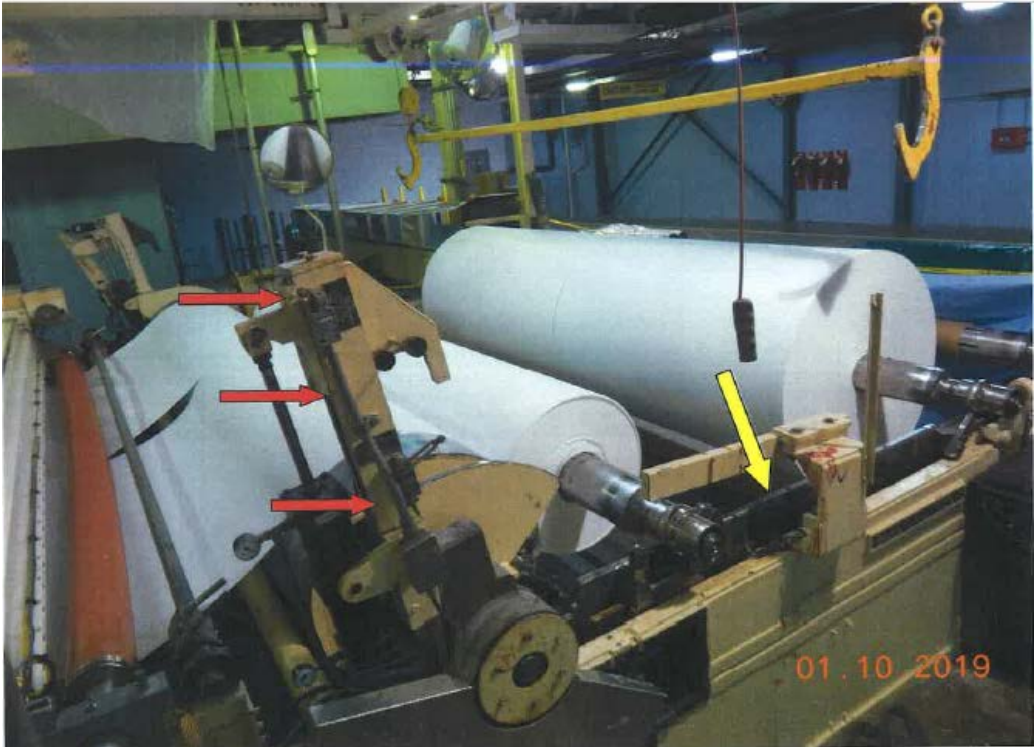
The employer was using a plastic yellow awareness barrier chain to keep employees from being in the path of or contacting the moving parts of the wind-up machine. No other guarding was in place to keep employees out of the danger zone of the machine.

In that there was not adequate guarding to protect employees from leaning or reaching into the SL-2 wind-up machine. An employee was fatally injured after being crushed between the hydraulic primary arm and the frame of the machine.

Description: The photo shows the wind-up machine. The yellow arrow indicates the location where the victim's head was crushed when the primary arm (red box) came down and struck him. The green arrow indicates one of the posts that the yellow awareness chain was connected to, prior to the accident. The blue arrow indicates the trash can which employees used, that was behind the chain. The orange circle indicates the empty tape roll that was observed on the floor.

29 CFR 1910.212(a)(1): One or more methods of machine guarding was not provided to protect the operator and other employees in the machine area from hazards such as those created by point of operation, ingoing nip points, rotating parts, flying chips and sparks:
