A **16 year old male** employee **fell 120'** through a 2' X 3' gap in planking of a mast climber scaffold near a column on the inside nearest the building wall.

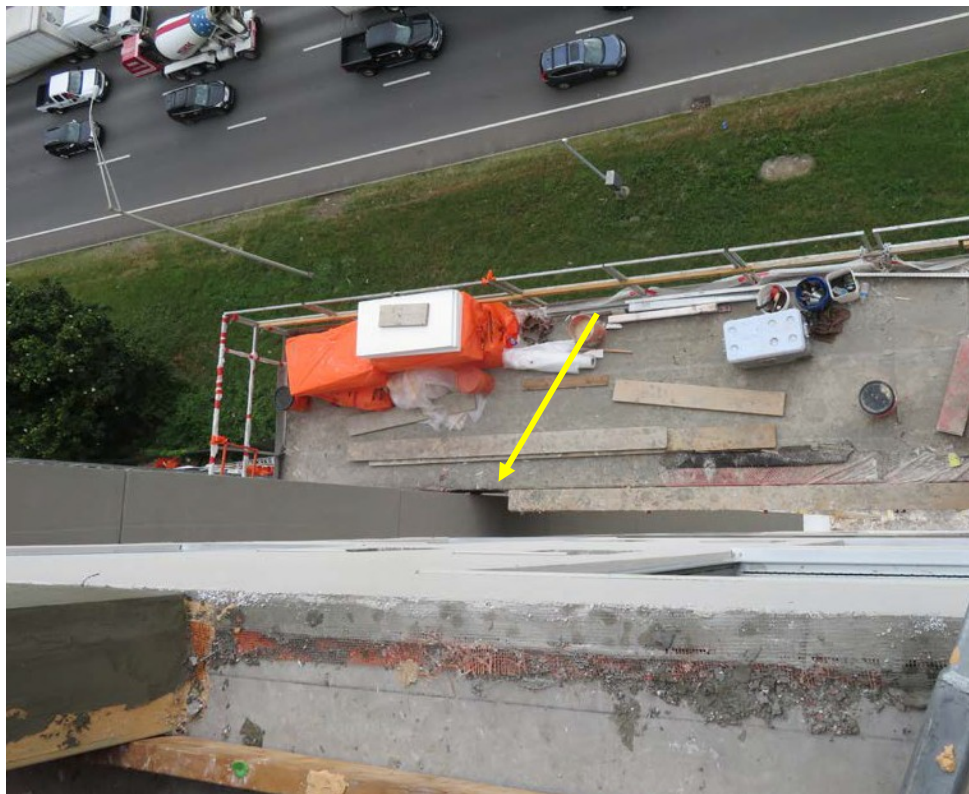
The scaffold involved in the incident was built around a column that protruded from the face of the building. It was determined that the column prevented the use of one of the outriggers used for planking that closed the gap between the scaffold work platform and the face of the building. The maximum allowable gap between the scaffold and the face of the building for plaster work is 18". The scaffold work platform was erected 24" from the face of the building due to the column preventing it being any closer. However, with the use of outriggers and 10" wide planks, the gap was closed to 14". As such, EZ Scaffold had designed, provided, installed, and trained the competent person for Carlos Cortes dba Cortes Plastering in the installation and use of the attachment. The attachment allowed for planking and safe access around objects such as columns by providing additional outriggers and cross members. It was determined that the attachment was installed and still in place when EZ Scaffold released the mast climber scaffold to the control of Carlos Cortes dba Cortes Plastering. However, it was determined that the attachment was removed before the scaffold ever left the ground and was never replaced.

Without the manufacturer's attachment, the foreman chose to lay a plank diagonally from the decking to the last available outrigger spanning from the face of the column towards the face of the building. The diagonal plank was on top of the work platform as well as another plank that was already secured in the last outrigger. The diagonal plank had no pin or other means of being secure. Also, it did not completely close the 2'X3' gap near the column and could be easily moved due to friction of the scaffold's normal movement.

In that no planking or decking was provided near the column that blocked an outrigger support that created an approximate 3' x 2' hole an employee fell through exceeding the 18" maximum.

Employee fell through gap at column

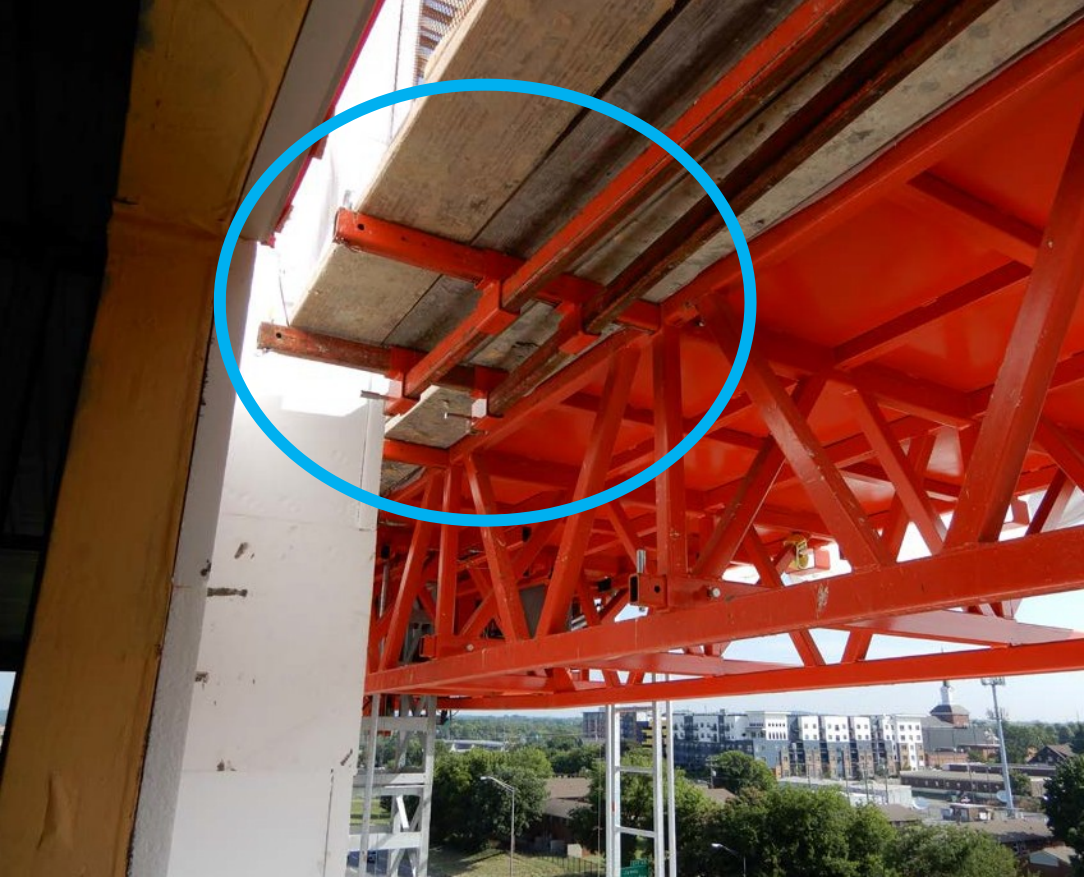
Manufacturer attachment in use on follow up inspection
