A **39 year old male** employee **fell through a fiberglass skylight** during demolition of a metal building. The employee fell approximately 18 feet from the rooftop to the concrete floor below.

6 Fall through skylight--Inspection #1472242 John Hurd

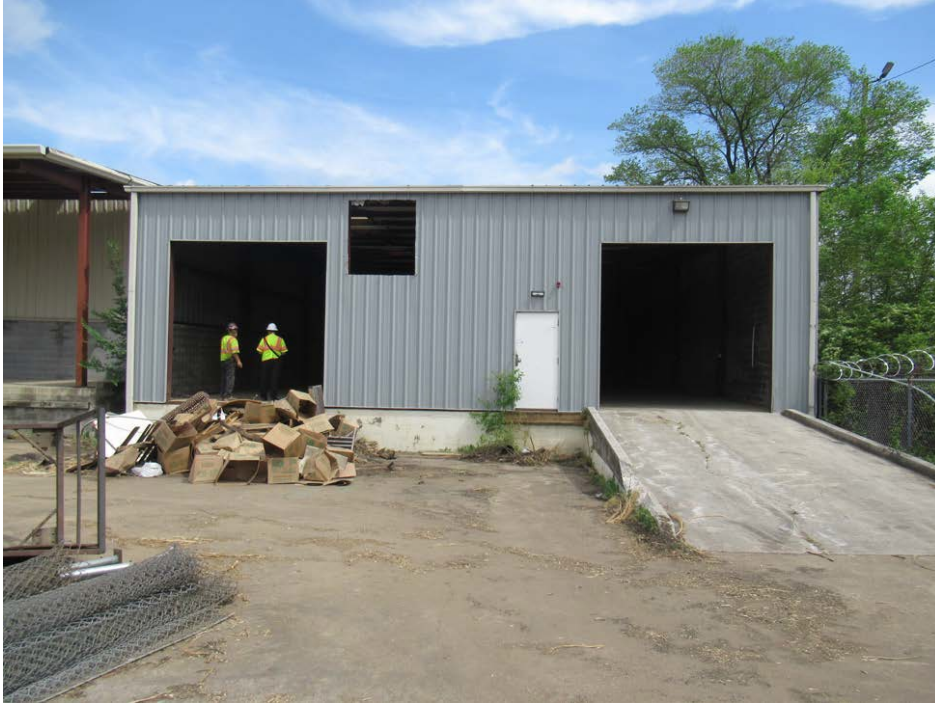
The employees accessed the roof with a JLG 420AJ aerial lift that was operated by the owner. While in the aerial lift basket neither of the employees utilized or had access to any form of fall protection. The employees were tasked with removing the screws from the metal roof so that the panels could be salvaged without damaging them. While on the roof neither employee utilized or had access to fall protection. After the employees exited the lift basket, one began to unscrew the first set of screws on the south side of the roof. The second employee began walking towards the north end of the roof. It was at this time that the employee stepped onto the skylight in the northeast corner of the roof. The employee fell through the skylight approximately 18 feet to the lower level, landing on the concrete floor below.

In that two employees were working on a rooftop that had 8 unguarded skylights, one of the employees fell through a skylight approximately 18 feet to the lower level resulting in a fatality.

29 CFR 1926.501(b)(4)(i): Each employee on walking/working surfaces was not protected from falling through holes (including skylights), more than six feet (1.8 m) above lower levels, by personal fall arrest systems, covers, or guardrail systems erected around such holes.

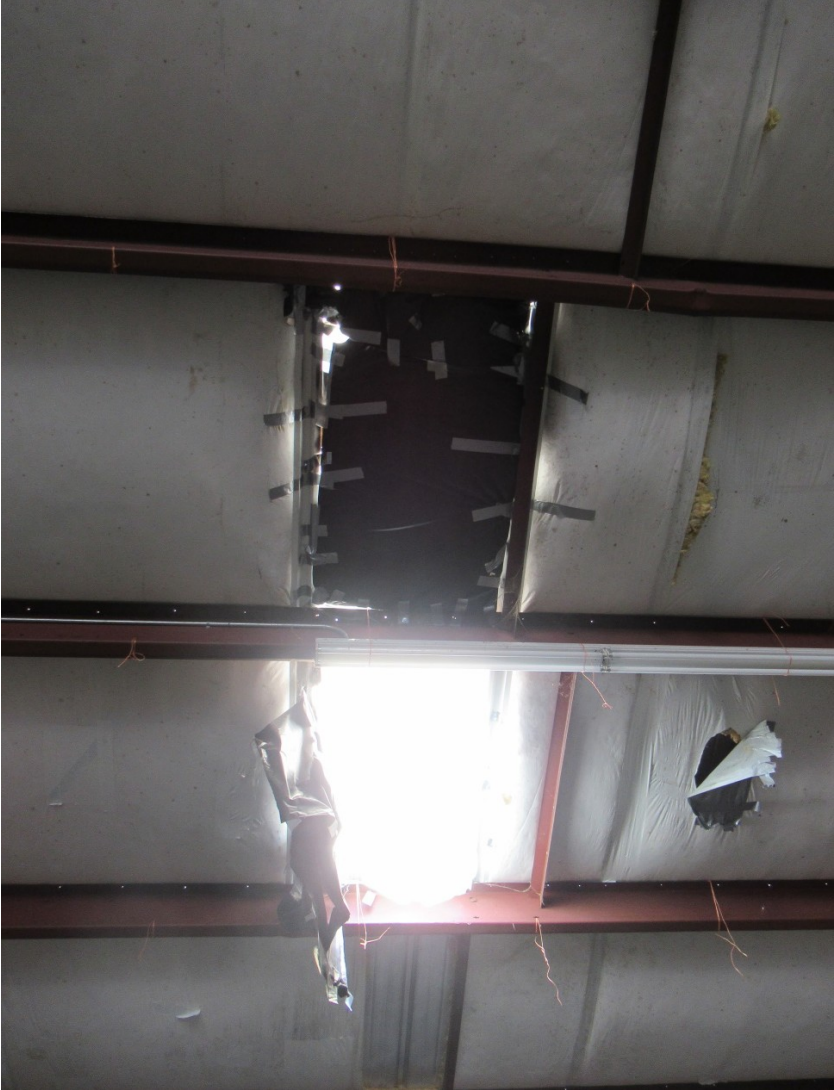
The two employees began working on the roof of an intact warehouse that measured approximately 5,000 square feet and was located on the northeast side of the work site. The warehouse had a steel beam frame with flat concrete floors. The walls of the warehouse were partially constructed of cinder block and metal sheathing with the east wall composed entirely of cinder blocks. The entrance to the warehouse was two roll up doors located on the south side of the structure. The roof of the warehouse was flat, made of metal, and measured approximately 18 feet above the lower level. On the roof were eight unguarded, 12 foot by 4 foot fiberglass skylights.

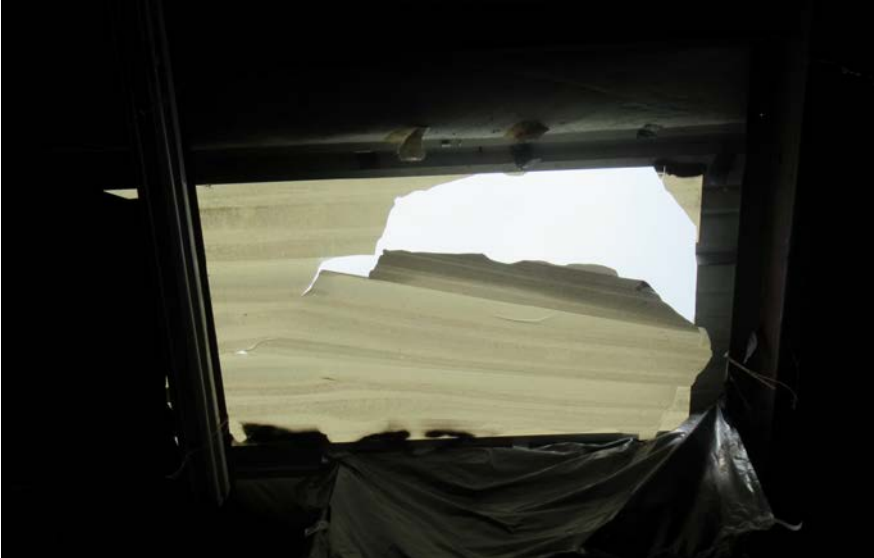
In that two employees that were accessing the roof 18 feet above the ground by the use of an articulating boom lift were not provided fall protection to use while in the lift.

29 CFR 1926.453(b)(2)(v): A body belt was not worn and/or a lanyard was not attached to the boom or basket when working from an aerial lift.
