A **36 year old male** employee **fell** approximately 55' through the roof to the 3rd floor decking of the building. This contractor was hired to remove rotted wood beams, columns, joists, and decking at an existing 7 story cold-storage building which was being remodeled into an apartment complex.

Fall--Insp # 1516301 Gray's Framing, LLC

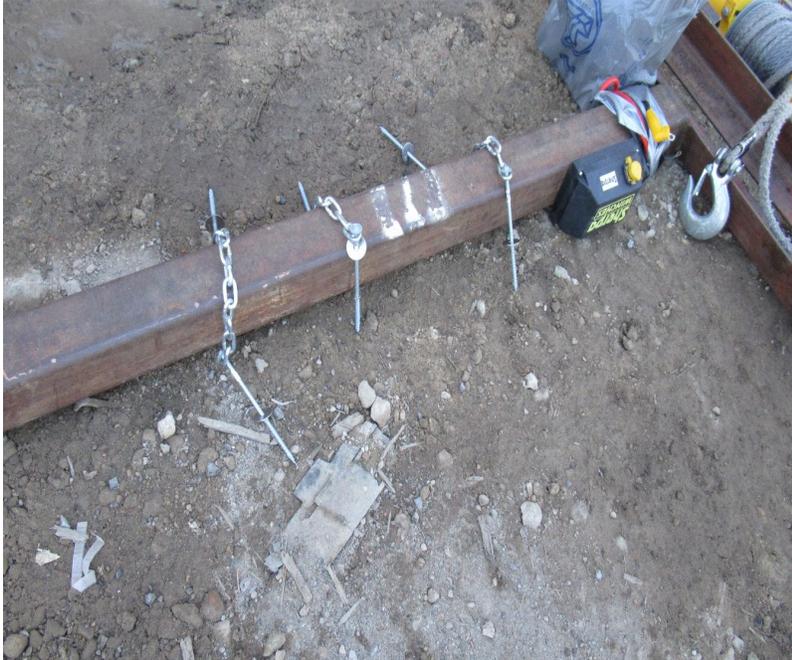
The crew each grabbed the 'T'-shaped base and started maneuvering the winch and base from the hoist area opening towards the west section of the roof. They stayed on the plywood walkway. At a point where the crew was approximately 20-25 feet away from the hoist area opening, the victim fell through the roof, and landed on the 3rd floor decking approximately 55 feet below. The victim fell through a section of rotted roof decking.

In that while on the roof moving a winch, the work crew, consisting of a supervisor and three carpenters, was not utilizing fall protection. One employee was fatally injured when he fell through the roof approximately 55 feet. The employee was wearing a personal fall arrest system (PFAS) full body harness and lanyard but was not tied off to an anchor point.

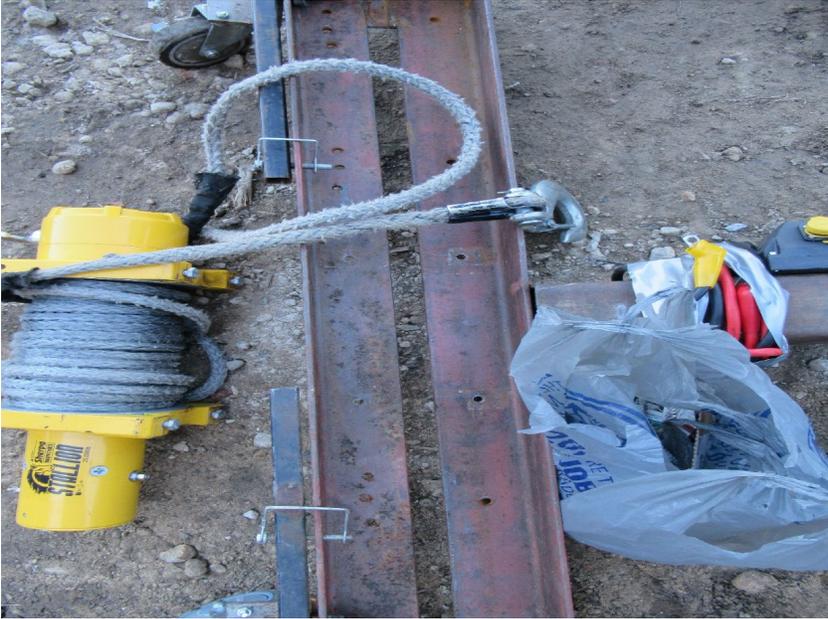
The winch was mounted on a shop-made 'T'-shaped base made of 4-inch by 4-inch by 3/8-inch thick steel square tubing, approximately 123 inches long. The crosspiece of the 'T' was fabricated with four sections of 3 1/2-inch by 3 1/2-inch by 1.4-inch thick angle stock (two short sections and two long sections). The angle stock was welded together to form a rectangle approximately 54 1/2 inches long by approximately eight inches wide. Additional holes were drilled in the angle stock for mounting the base to the roof beams.

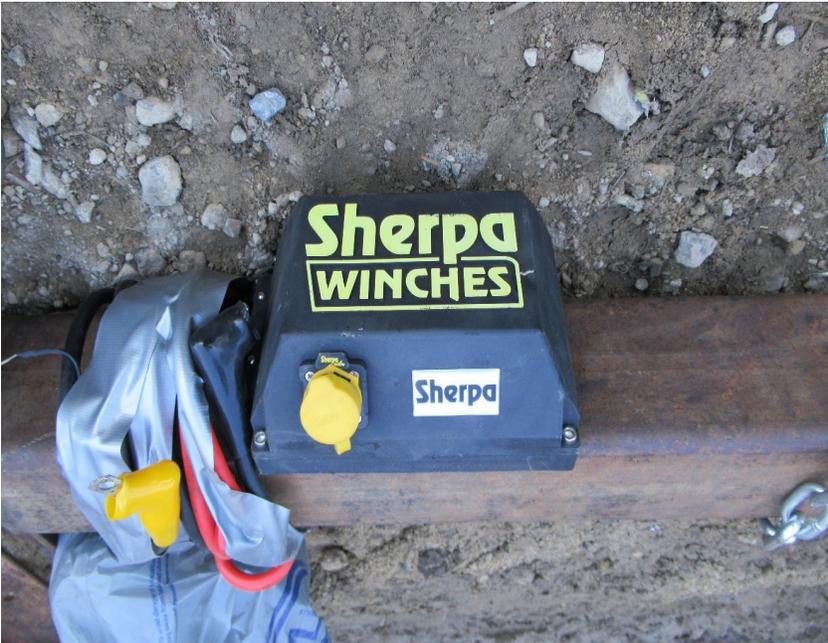
On the roof, the crew were each wearing their personal fall arrest system (PFAS) full body harnesses and lanyards, but no one was tied off to an anchor. The crew walked on the plywood walkway to the hoist area opening in the roof where the Sherpa Winch was located. Sheets of plywood were laid on the existing wood roof decking and followed a path of existing sound wooden beams that supported the existing wood roof decking.
