Struck by concrete forms—Insp # 1602868 Lee Company

A **35 year old male** employee was operating a trimble unit to set the plumbing penetration point on the 31st floor when he was **struck by a dropped load of new concrete formwork.**

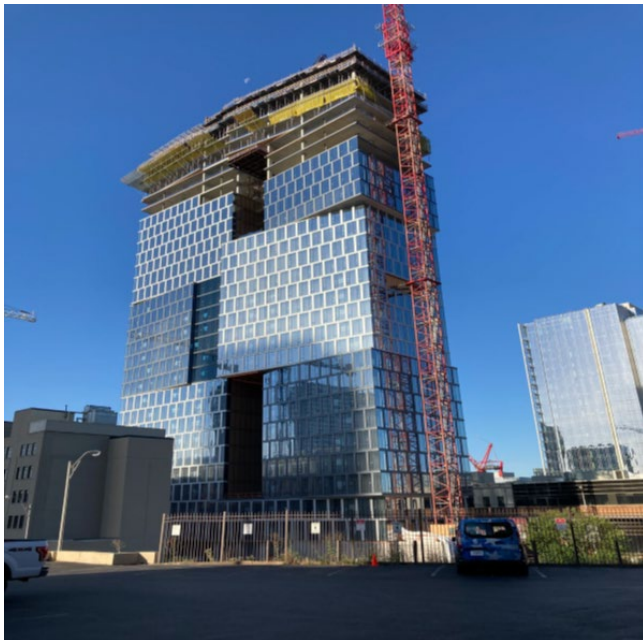
Citation(s) as Originally Issued

A complete inspection was conducted at the accident scene. Some of the items cited may not directly relate to the fatality.

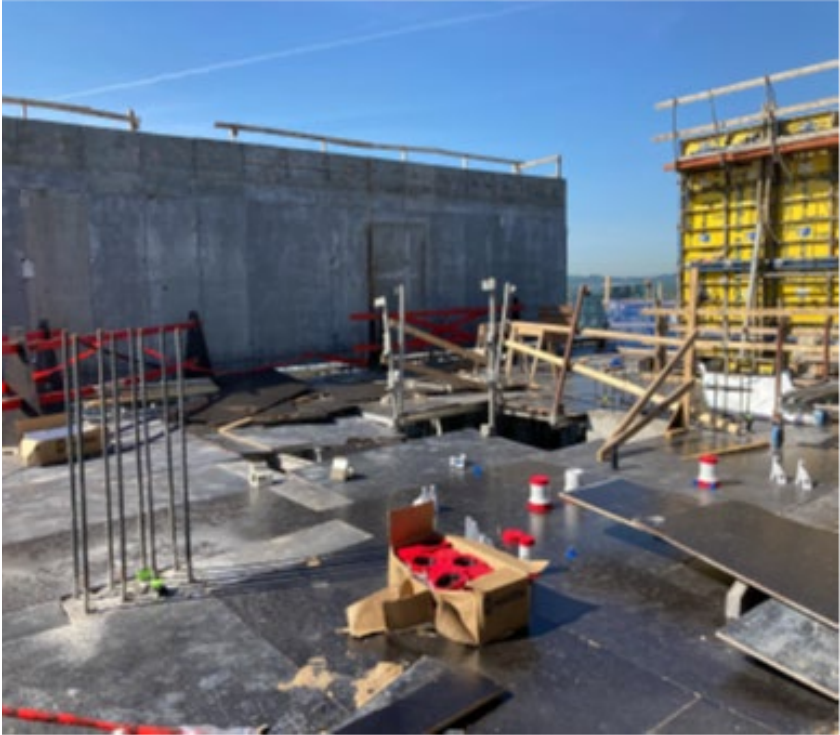
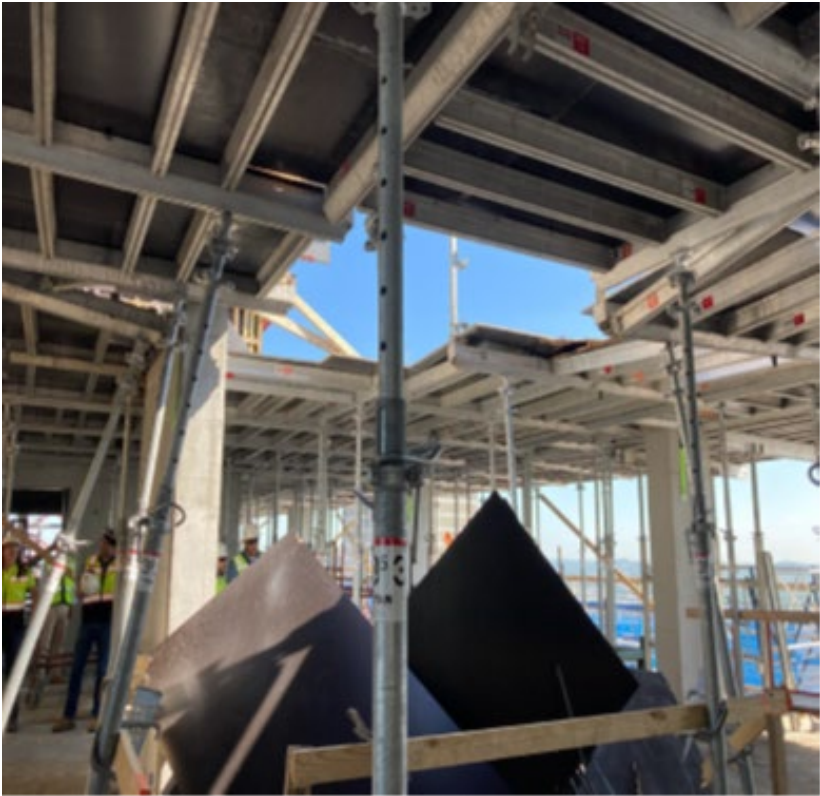
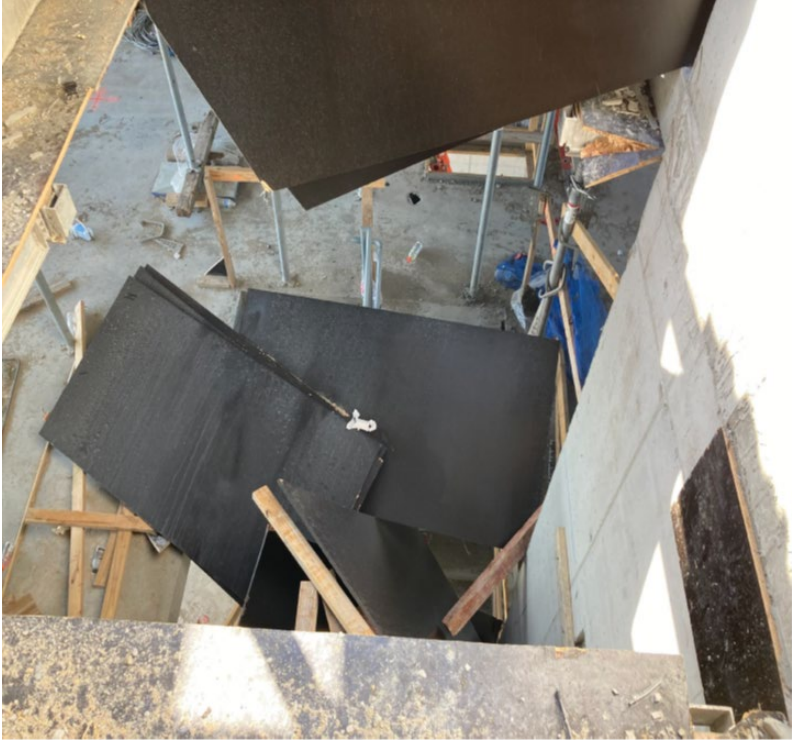
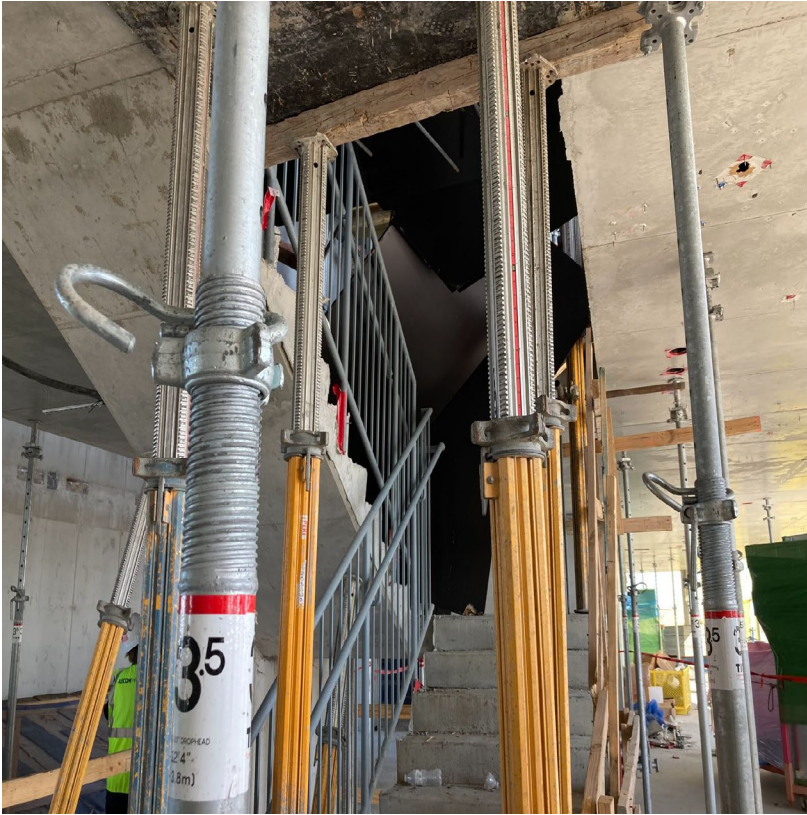
Employee was struck in the back of the head with his back turned to a load of multiple 4' x 8' concrete forms being offloaded on the 31st floor by a crane operator. The employee was pushed by the force of the strike and fell approximately 30 feet down a stairwell shaft that wasn't completed. On the 28th floor is where the stairs in the stairwell shaft began. Employee struck his head on the steps and his legs struck the existing wooden stair railing on the outside perimeter of the stairs. Due to the force of the fall the employee's legs broke the top and middle rail of the 28th floor guardrail system. In addition, multiple 4' x 8' sections of the formwork fell down the unfinished stairwell shaft hitting multiple shoring posts and destroying the existing guardrail systems from the 31st to the 28th floor.

The only employee who saw the load before it fell was the rigger himself. He indicated that when the load was first picked up it was level and appeared to be rigged correctly. However, as the load was beginning to move towards the south side the load dispersed and fell from the rigging. Through interviews it was determined that the formwork was rigged with 20' nylon straps approximately 6 inches from the end of each stack using a single wrap choker hitch.

A choker hitch only compresses the load on 3 sides whereas a double wrap choker hitch compresses the load on all 4 sides providing better load control.

New formwork is extremely slippery by design to prevent concrete from sticking to it and loses its non-stick qualities with use; the formwork that struck the victim was new and had never been used before. Without rigging that provided compression from all 4 sides the slippery load was able to move in the single wrap choker hitch displacing the load and ultimately dumping the load below. The rigger did not communicate a safe route and exposed employees to the hoisted load as it traveled directly over them as they worked on the 31st floor.
