A 20 year old male general laborer was fatally injured after falling through the roof decking of a high school gym approximately 30'3". The victim's duties were clearing away scraps of material, tools and trash. The project was a roof replacement. The job for which Jr Roofing & Construction was hired was to replace the iso and PVC layers.

Fall through a roof deck—Insp # 1703349 Jr. Roofing & Construction LLC

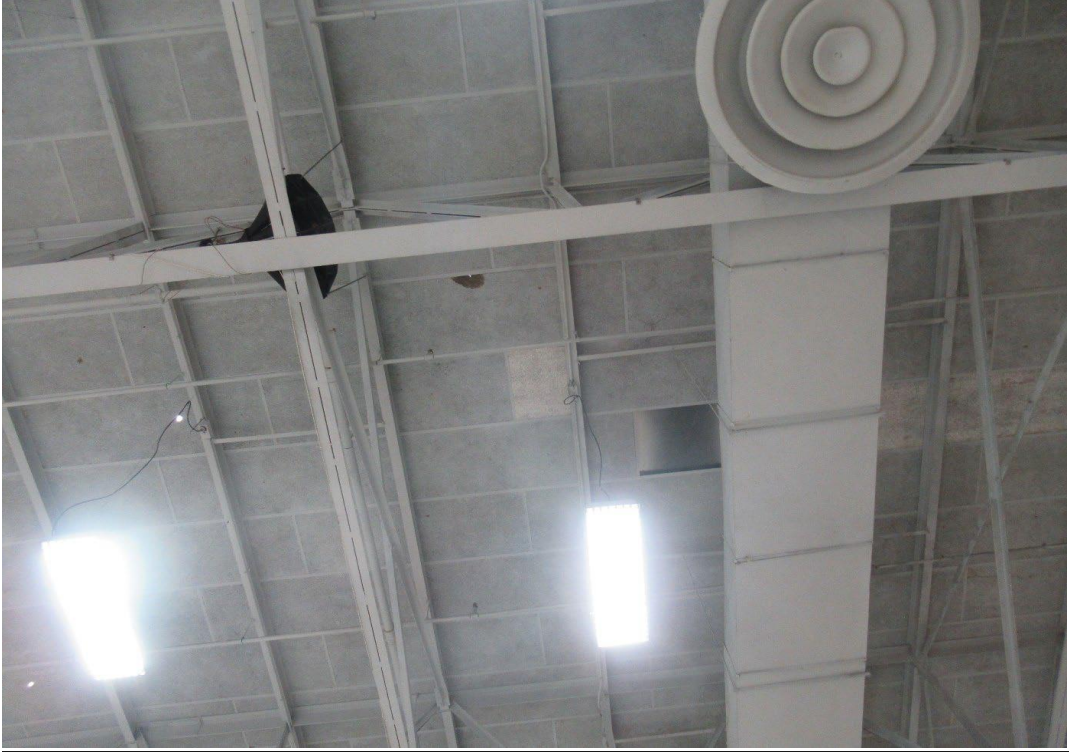
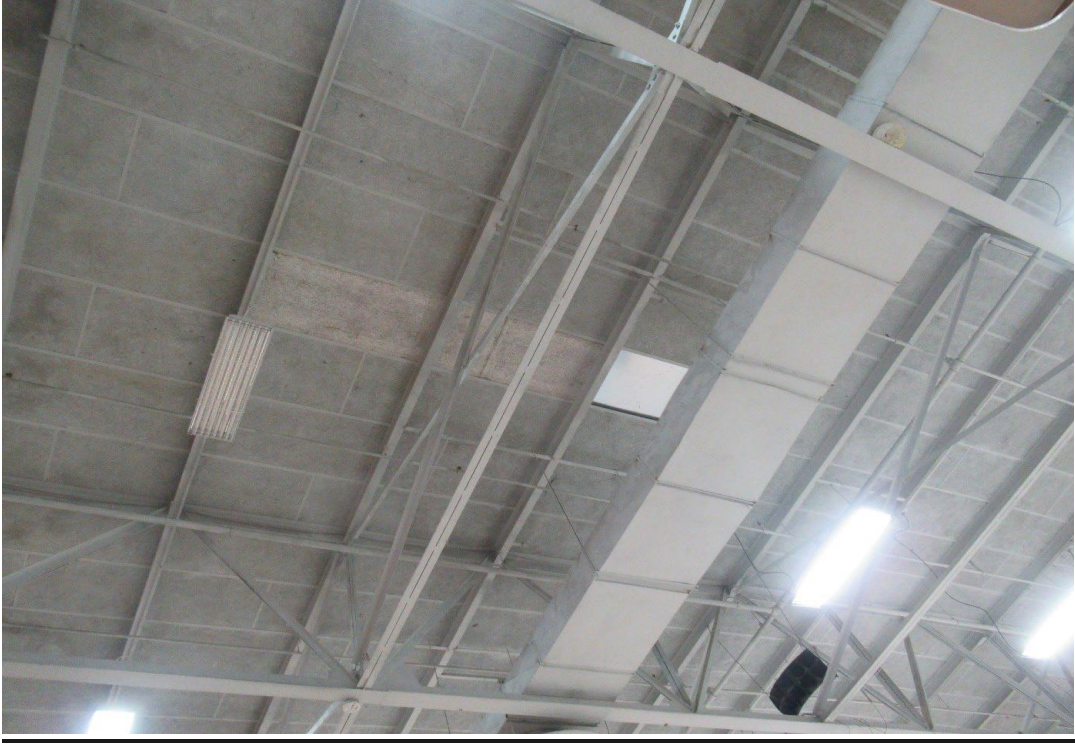
The site superintendent for the general contractor on the project was aware that the decking of the gymnasium roof had been identified as a potential hazard after work had begun on that section of the roof. The decking appeared as though it had absorbed a lot of moisture and that apparent water damage was visible before the iso and membrane layers were removed from the decking. When the damage was noted, it was flagged off and a site-wide formal stand-down was held using bilingual subcontractors to translate the issue into Spanish for the monolingual workers.

Several coworkers of the victim were on the roof at the same time on the day of the accident and none of those coworkers directly saw when he fell through the decking. One employee stated that he heard a sound like something breaking, and when he looked around, he saw the hole where the victim had previously been standing. The decking broke underneath the victim and he fell directly through to the gymnasium floor. The place where he had been working at the time had been an area where the iso and membrane layers had already been removed. New layers of the

iso and membrane had not been placed down in that spot yet when he fell; he was standing on only the tectum decking. The area had not been identified by either Jr Roofing & Construction or the general contractor as being an area requiring a personal fall arrest system, due to its distance from the edges of the roof and the visual appearance of the roof surface in that location. Fall protection in use at the time of the accident in the middle of the tectum-decked section of the gymnasium roof consisted of a safety monitor, employee of the general contractor and warning line system. Personal fall arrest systems were required on the metal-decked areas at the edges of the roof, the single tectum-decked edge of the roof, and the potentially water damaged area in the middle of the roof. (note - not the area where the victim fell through.) The victim was not wearing a fall protection harness at the time of his accident.
