**#21: Struck By – Inspection #996343**

A 77 year old male employee was struck by a clasp while unloading lawn mowers from an enclosed shipping trailer. The lawn mowers are ordered from the manufacturer and delivered to the wholesaler, on a metal pallet, by tractor trailer. Employees use a 115 foot manila rope with a metal clasp to pull the pallet to the opening of the trailer, so that the forks can be placed under the metal pallets for unloading. Employees wrap the rope around an opening on the pallet by connecting the clasp back to the standing part of the rope. The other end of the rope is attached to the forklift. The forklift is then used to pull the metal pallet containing the lawn mower to the opening of the trailer. On the day of the incident, the victim was providing guidance on how to unload the mowers from the trailer. The manila rope and clasp was connected to a metal pallet and pulled to the opening of the trailer with the forklift. Four mowers were unloaded without incident earlier in the day. While unloading the fifth mower the victim was standing on the ground between the forklift and the open door of the trailer while communicating with the employee inside the tra

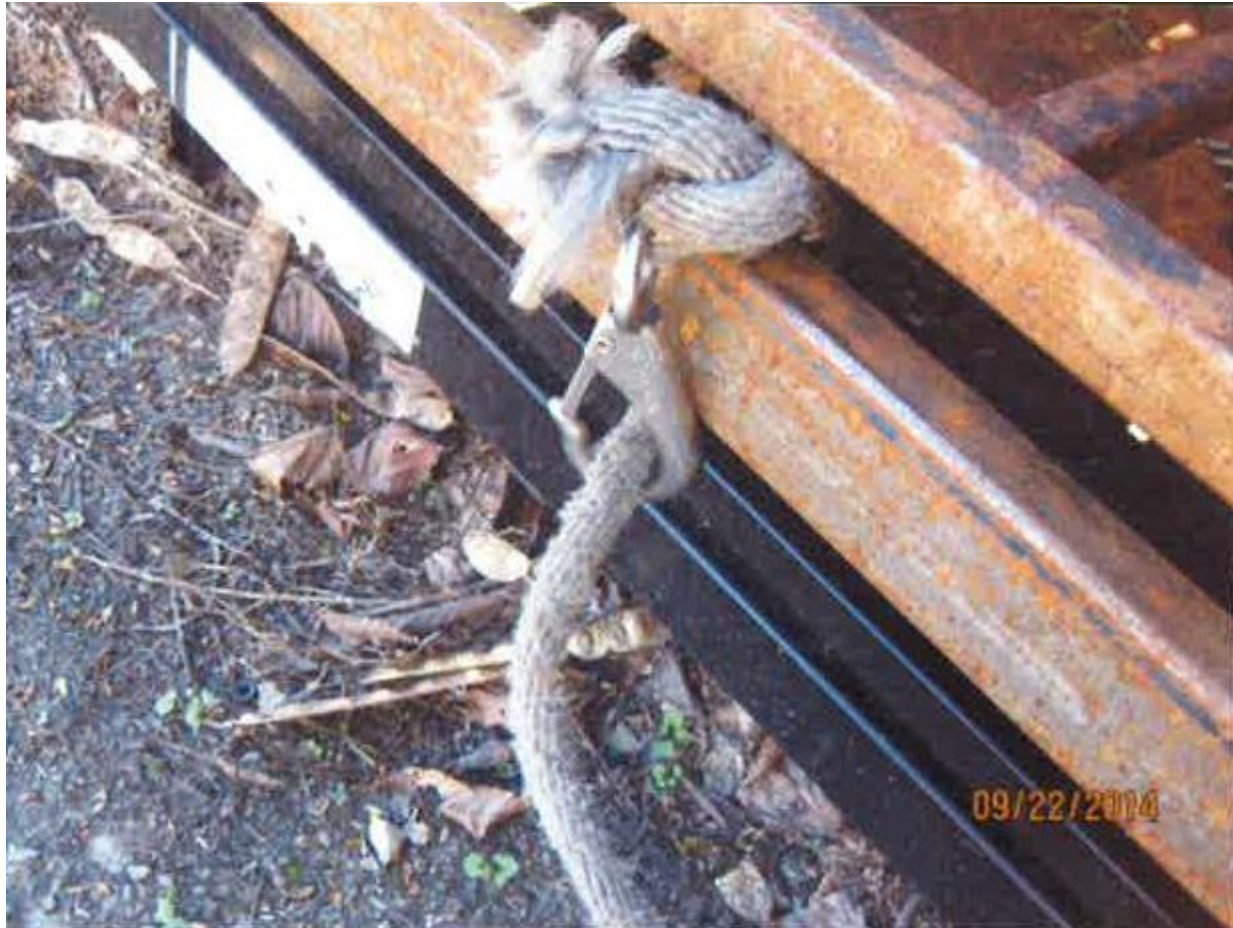
Photo 1 of 1: Manila rope and metal clasp used to pull lawn mowers on metal pallets to the tractor trailer opening for unloading.

Item 1 T.C.A. 50-3-105(1)	The employer did not furnish employment and a place of employment which were free from recognized hazards that were causing or likely to cause death or serious physical harm to employees. In that the employees tied a rope with a metal clasp to a metal frame pallet containing zero turn lawn mowers inside an enclosed trailer while using a forklift to pull the pallets to the end of the trailer for unloading. Feasible abatement methods, among others are: a) use of a pallet puller; and/or, b) install a loading dock.
Item 2 1910.23(b)(1)	Every wall opening from which there is a drop of more than 4 feet was not guarded. In that, the employees are exposed to a 12 foot fall when accessing the mezzanine area located above the sales office.
