#23: Fall – Inspection #1001482

A **52 year old male** employee fell 26 feet to his death into a waste vault. Two employees were in the process of removing a bull horn attachment from the transfer bell on a lifting device so that a grapple attachment could be installed. The grapple attachment was used to remove the cover from the waste vault. The victim was troubleshooting the hook of the transfer bell and bull horn attachment while 34 inches from the floor opening into the waste vault. The victim was required to walk in close proximity to the floor opening to troubleshoot the removal of the attachment. When the victim walked to the far side of the transfer bell he took a few steps back and fell into the floor opening. The victim was wearing a full body harness, as he had used his fall protection while climbing the transfer bell prior to its removal from the vault. The employer had provided anchor points around the opening for the use of fall protection and had trained employees on the proper use of the fall arrest systems. However, employees interviewed could not consistently explain the company policy of when to use the supplied fall protection, nor were there any periodic inspe

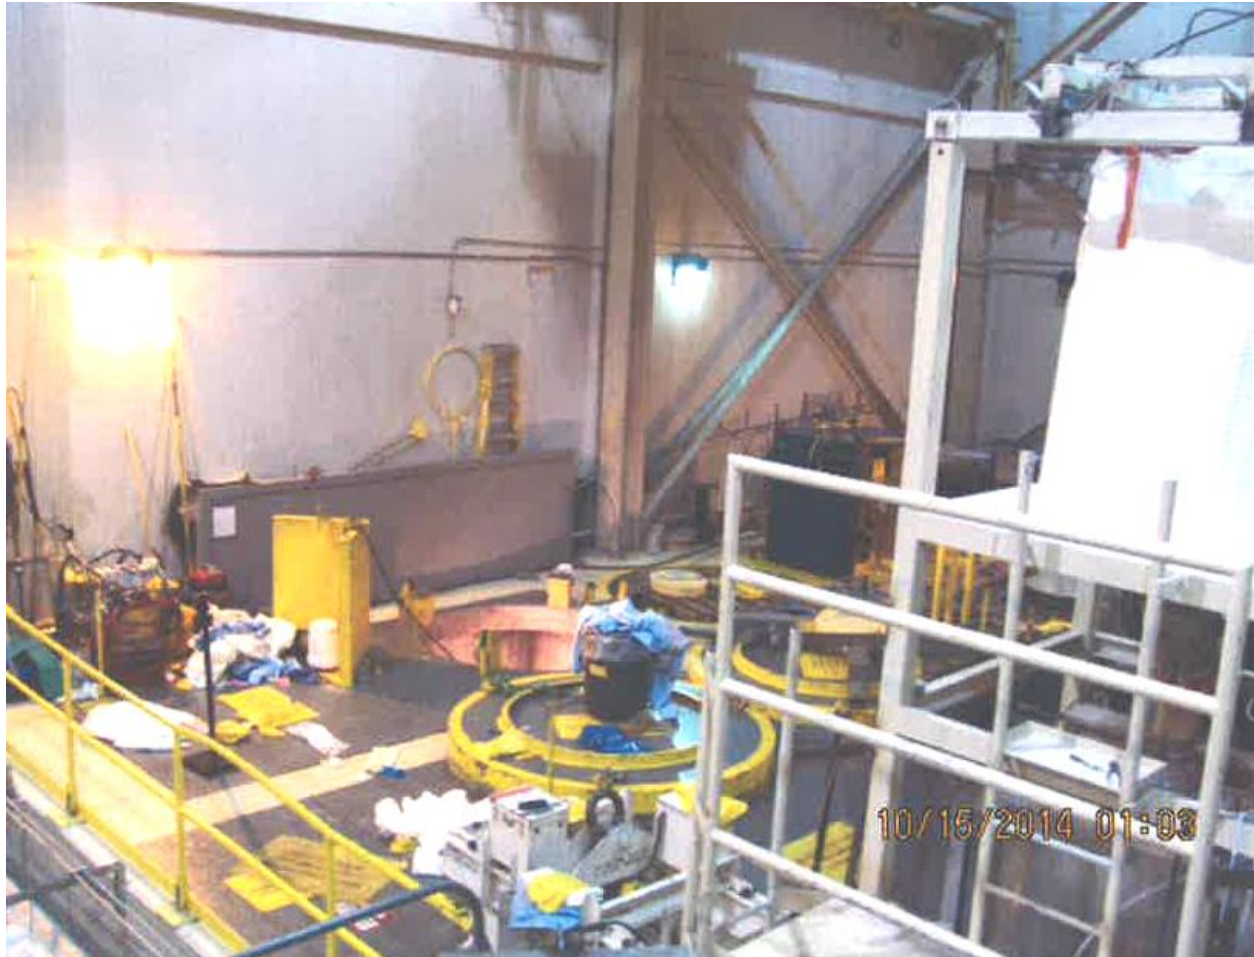
Photo 1 of 1: Employee fell 26 feet to his death into a waste vault

Item 1 1910.23(a)(8)	Every floor opening into which persons can accidentally walk was not guarded: In that two employees were exposed to a floor opening fall hazard at the 116’ area. The two employees were working near a transfer vault that had an opening diameter of 103.75”.
Item 2 1910.146(c)(1)	The employer did not evaluate the workplace to determine if any spaces were permit-required confined spaces: In that an adequate evaluation of the transfer vault was not completed as the means of entry, design for continuous occupancy, and hazardous atmosphere were not acknowledged in order to effectively define the hazards of the space.
