26 Struck by ---Inspection #1316665 Superior Traffic Control LLC

A **34 year old male** was fatally injured when he was **struck by** a tractor trailer after it hit the concrete barrier wall, flipped on its side and slid into the victim while he was standing beside his company truck.

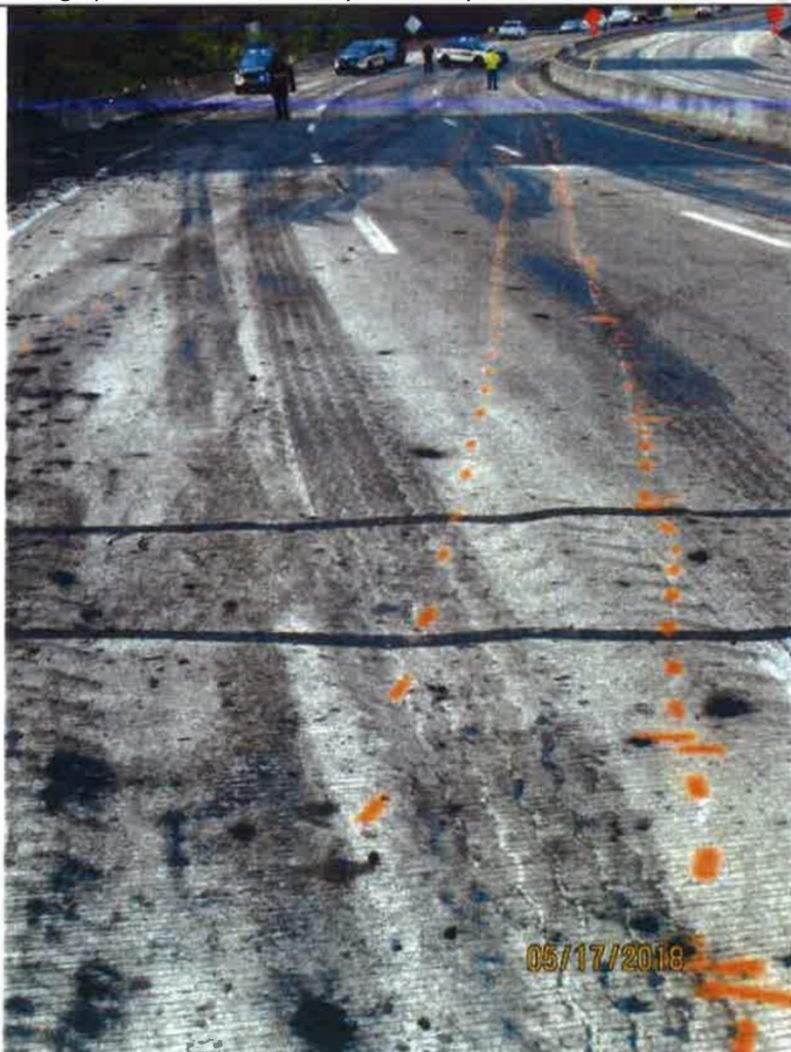
This photo shows the incident scene. The orange lines were painted by the Tennessee Highway Patrol and show the path the vehicle traveled after striking the concrete barrier in the middle of the highway and tipping onto its passenger side. Vehicle recovery and road cleaning operations were already underway when the CSHO arrived on scene.
