A **39 year old male** employee was **crushed** when a 2,133 pound steel coil which he was loading onto the uncoiler machine by use of an overhead crane fell off the machine and landed on him.

13 crushed by steel coil--Inspection # 1422919 The Troxel Company

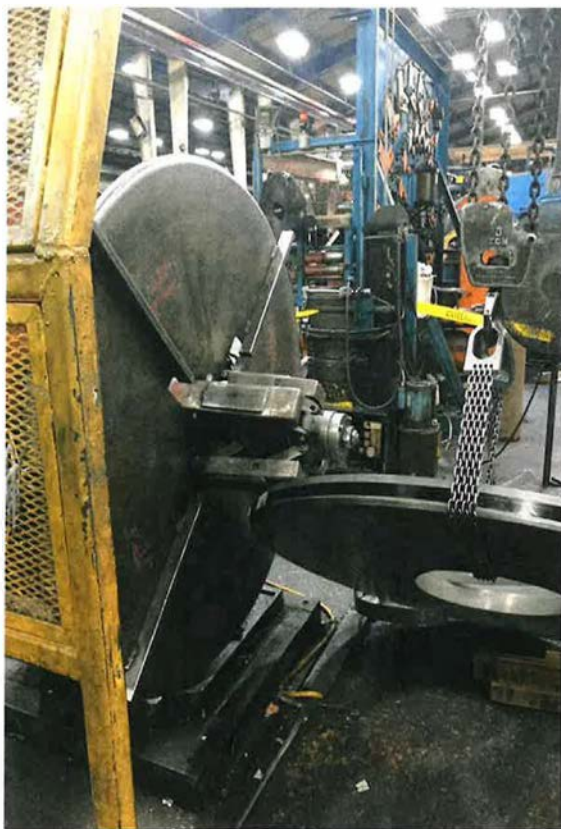
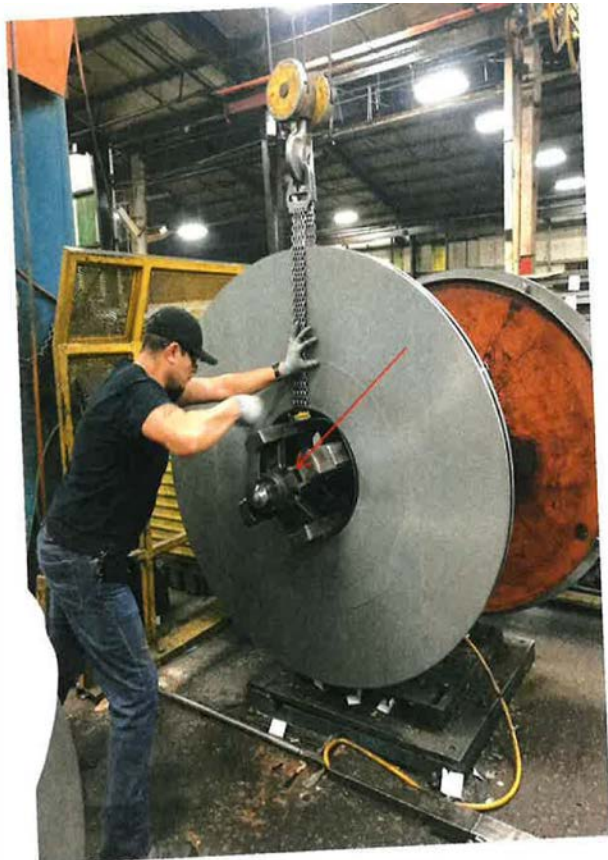
It appears that the victim was using the Budget 3 ton overhead crane and metal web sling to lift a 2133 pound, 2.36 wide, 60 inch diameter coil of steel onto the uncoiler machine. Without adequately securing the coil to the machine, he apparently attempted to unhitch the coil from the crane. The unsecured coil fell off the machine landing on him.

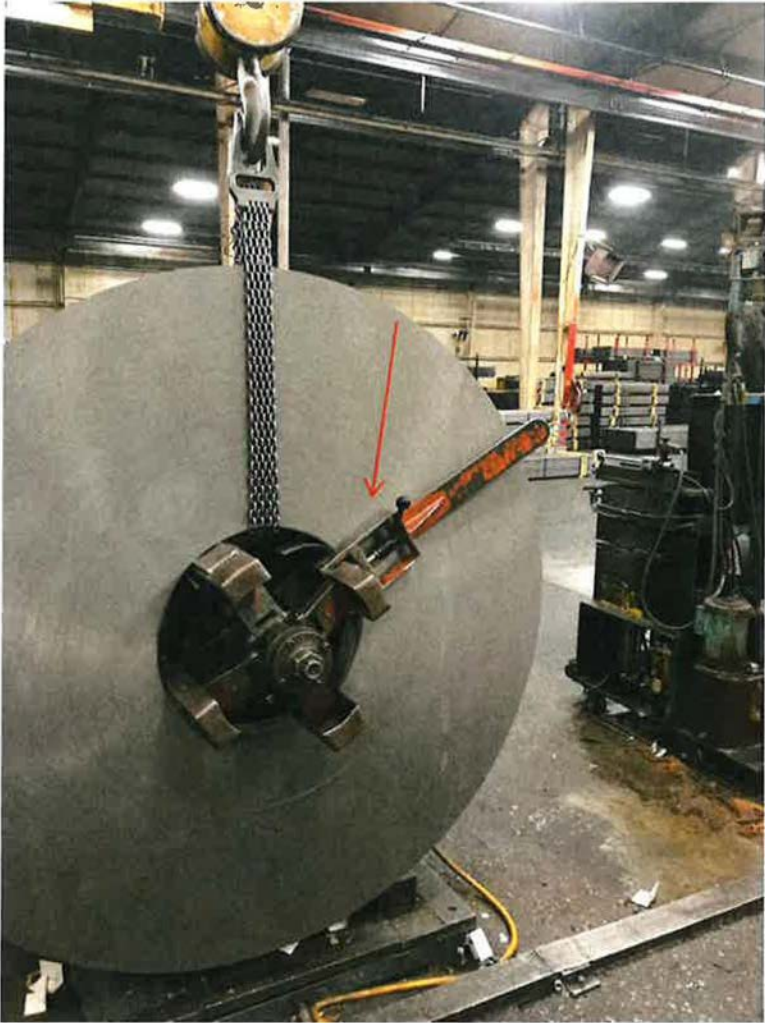
View south to north of coil on uncoiler with installed locking mechanism while still being held by chain strap and Jib Crane.

The correct procedure for loading coils onto the uncoiler is using the crane and sling to lift the coil in place with an expander through the center of the coil. The expander and another locking mechanism hold the coil in place. Once the coil is locked in place the sling is removed by releasing tension on the crane. This allows for one loop of the sling to be unattached. After the chain is detached, the crane is raised and the sling is removed from the coil. The coil is then ready to be fed into the mill for processing into steel tubes. At the end of the process, the finished steel tubing is received by a Racker. The Racker places the steel tubing on a shipping skid, bands the tubing to the skid, and moves the skid to the shipping department via forklift. The victim was considered a Racker.
