19. Crushed Between Parts of Tire Assembly Machine

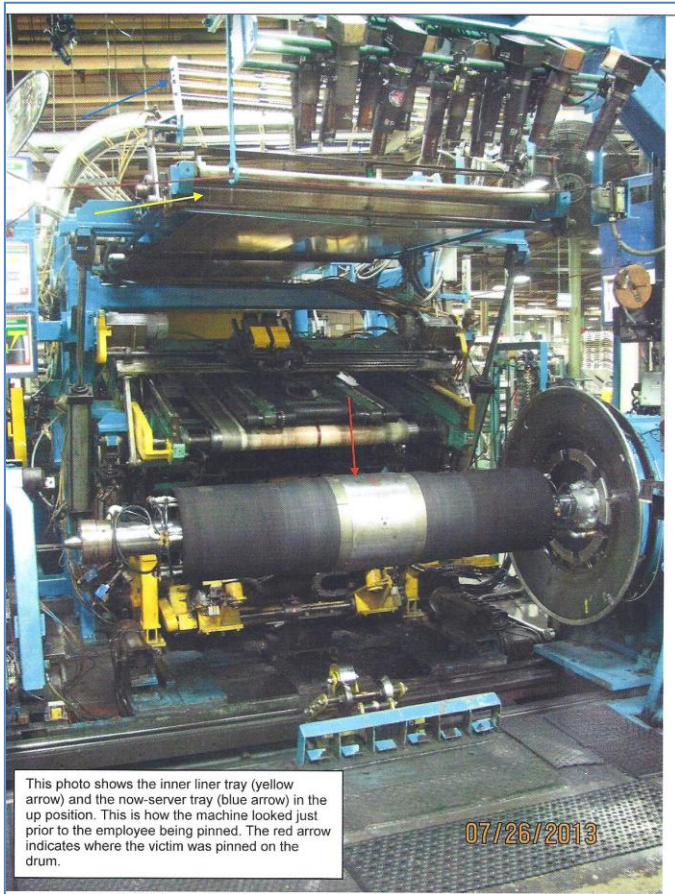
Before the incident

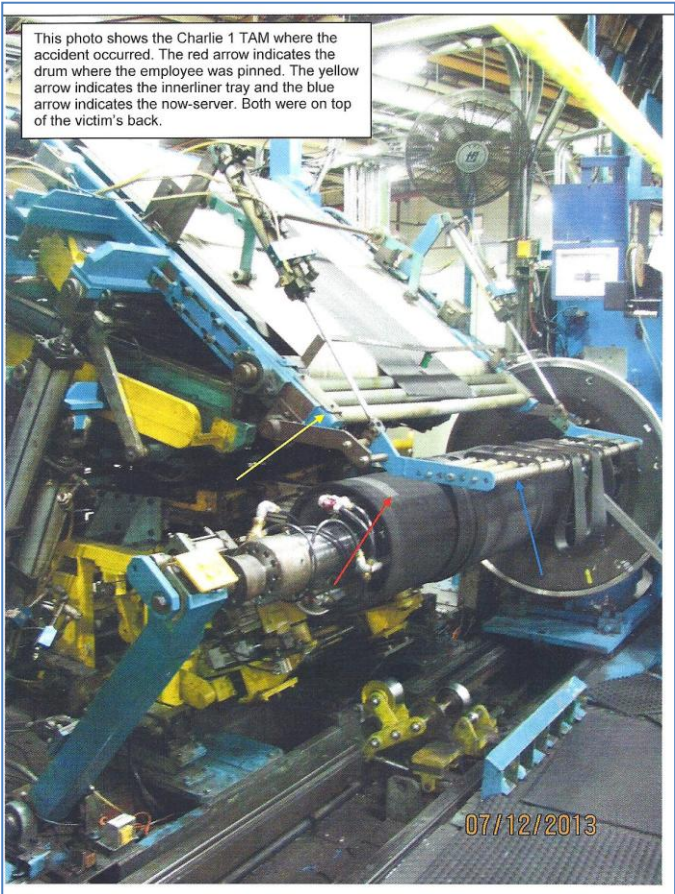
After the incident
