#13: Fall – Inspection #317782712

A **57 year old male** employee was injured when he fell from an elevated platform of a Crown order picker powered industrial truck (PIT). On the day of the incident, the victim was either picking up product for an order or he was checking numbers on products in the first aisle of the warehouse. Witnesses stated that the victim was wearing his personal fall arrest system (PFAS) full body harness earlier that day. During the TOSHA investigation it was found that the PFAS lanyard was tied to the anchor point of the PIT but the lanyard was not attached to the “D” ring on the back of the full body harness worn by the victim. The victim was found by a co-worker unresponsive with apparent head injuries. He was taken to a Memphis area hospital where he later passed away due to his injuries.

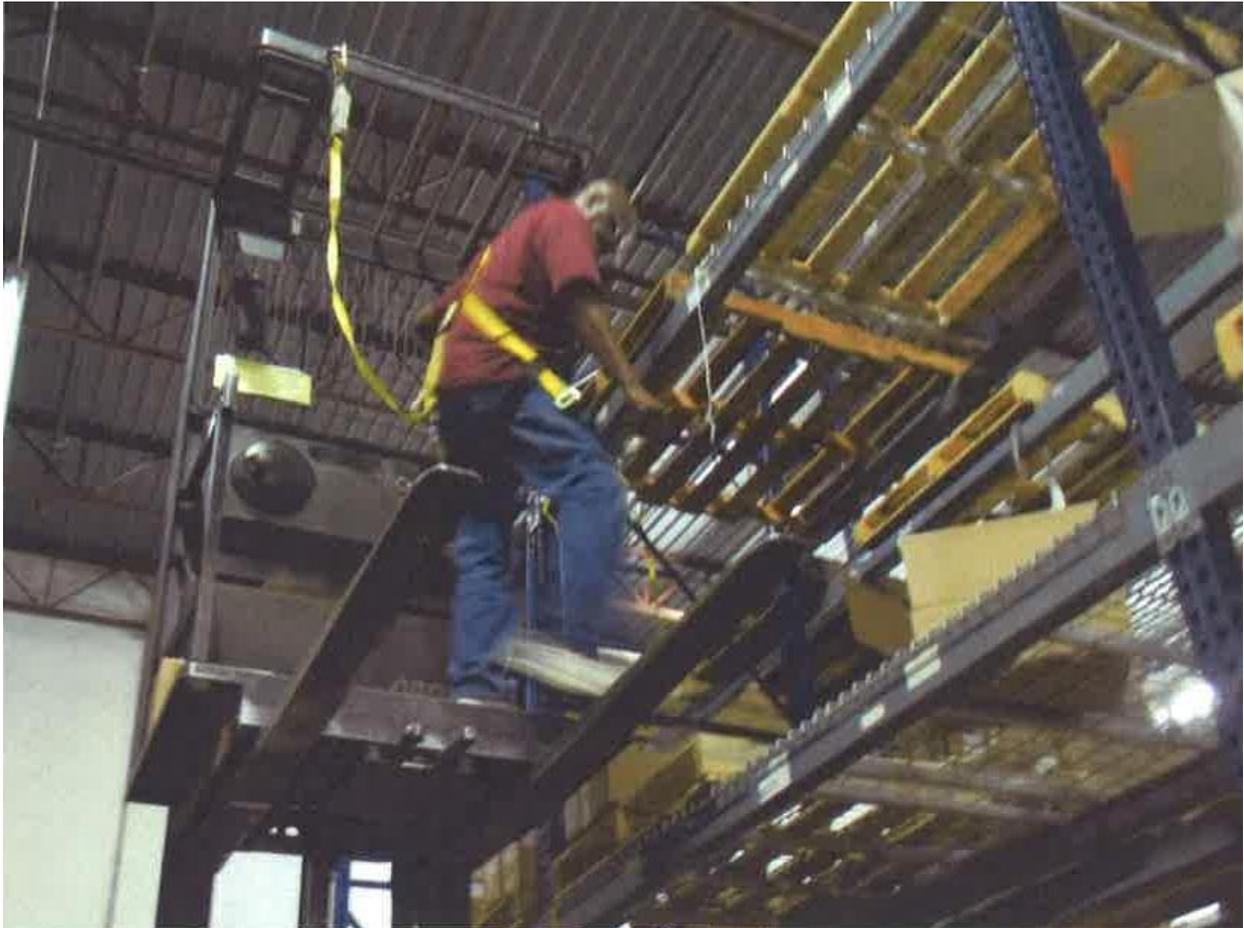
Photo 1 of 2 – Crown order picker powered industrial truck (PIT).

Item 1 1910.23(c)(1)	Open sided floors or platforms 4 feet or more above the adjacent floor or ground level were not guarded by standard railings (or the equivalent as specified in 29 CFR 1910.23(e)(3)(i) through (v)), on all open sides in that the employer did not ensure a material handler was protected from fall hazards while operating his order picker powered industrial truck (PIT) (i.e. cherry picker); the lanyard was not attached to the “D” ring on the back of his full body harness.
----------------------	-----------------------------------------------------------------------------------------------------------------------------------------------------------------------------------------------------------------------------------------------------------------------------------------------------------------------------------------------------------------------------------------------------------------------------------------------------------------------------------------

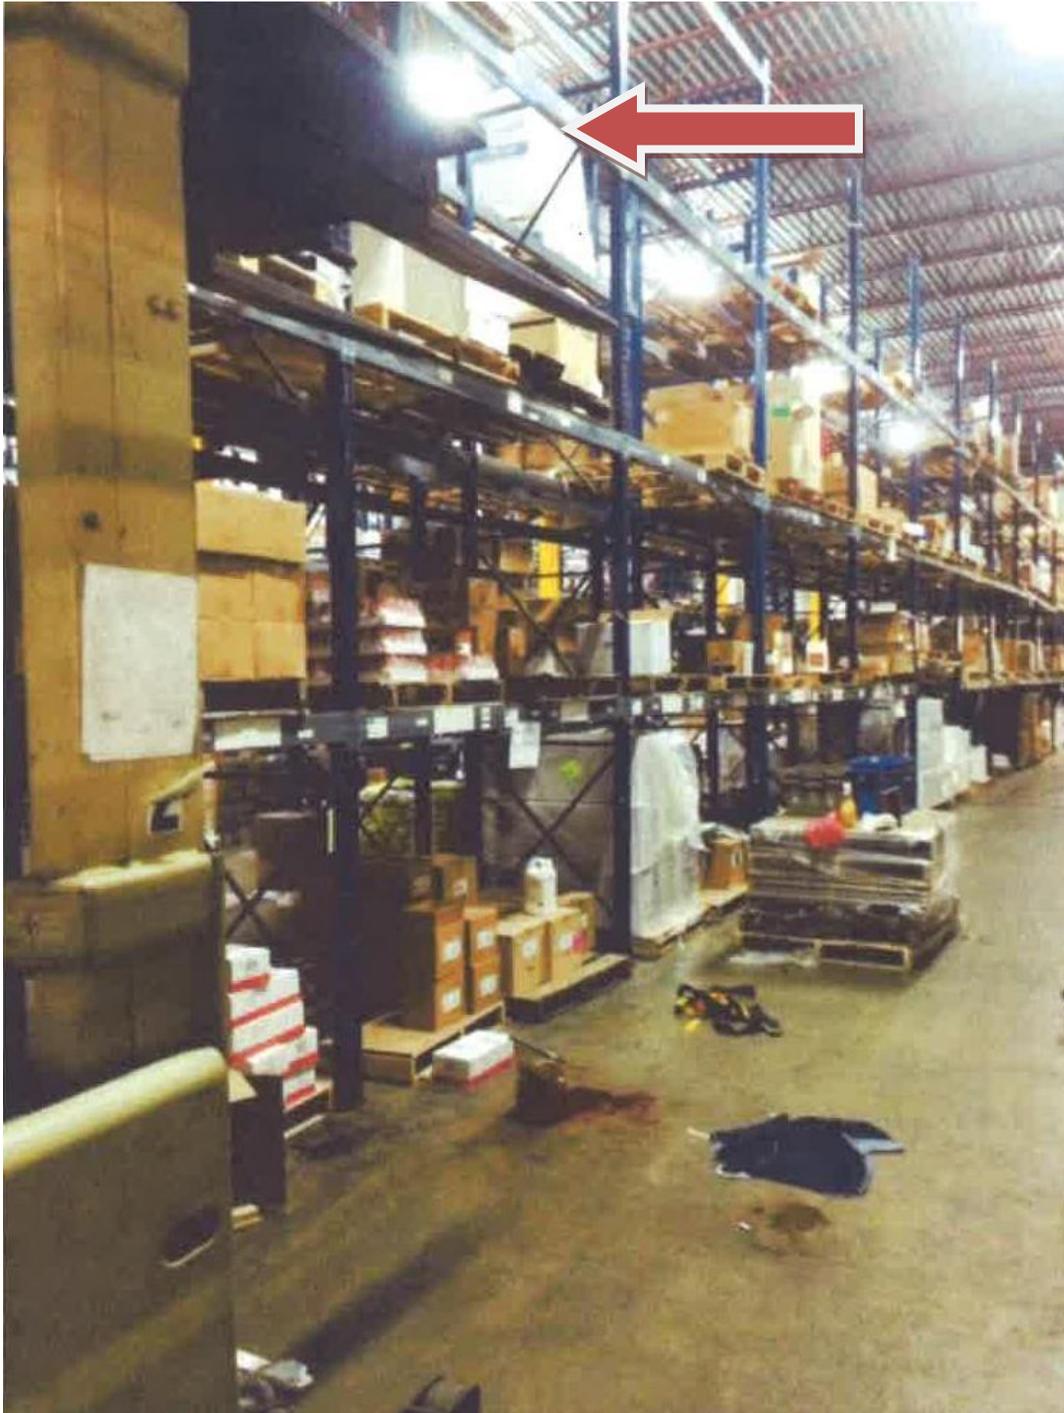
Photo 2 of 2 – The arrow points to the platform of the order picker where the victim fell.
