Fall through roof – Inspection #1113225

A **39 year old male** employee was fatally injured when he slipped while removing metal roofing and fell 25 feet to the concrete below. On the day of the accident, three employees were removing and replacing metal roofing panels on the roof of a single story building. The building's roof area was approximately 241 feet wide by 50 feet long, with a 1/12 pitch. The victim attempted to remove a three feet wide by 31 feet long metal roof section. As he was attempting to separate the butyl tape that was connecting the unscrewed piece of metal to a piece of metal roofing that was still attached, his foot slipped and he lost his balance, falling through a 3 foot wide by 31 foot long opening in the roof. Earlier in the day, the employees were wearing their fall protection, but the decision was made to remove the personal fall arrest systems to avoid becoming tangled in the tie-off ropes.

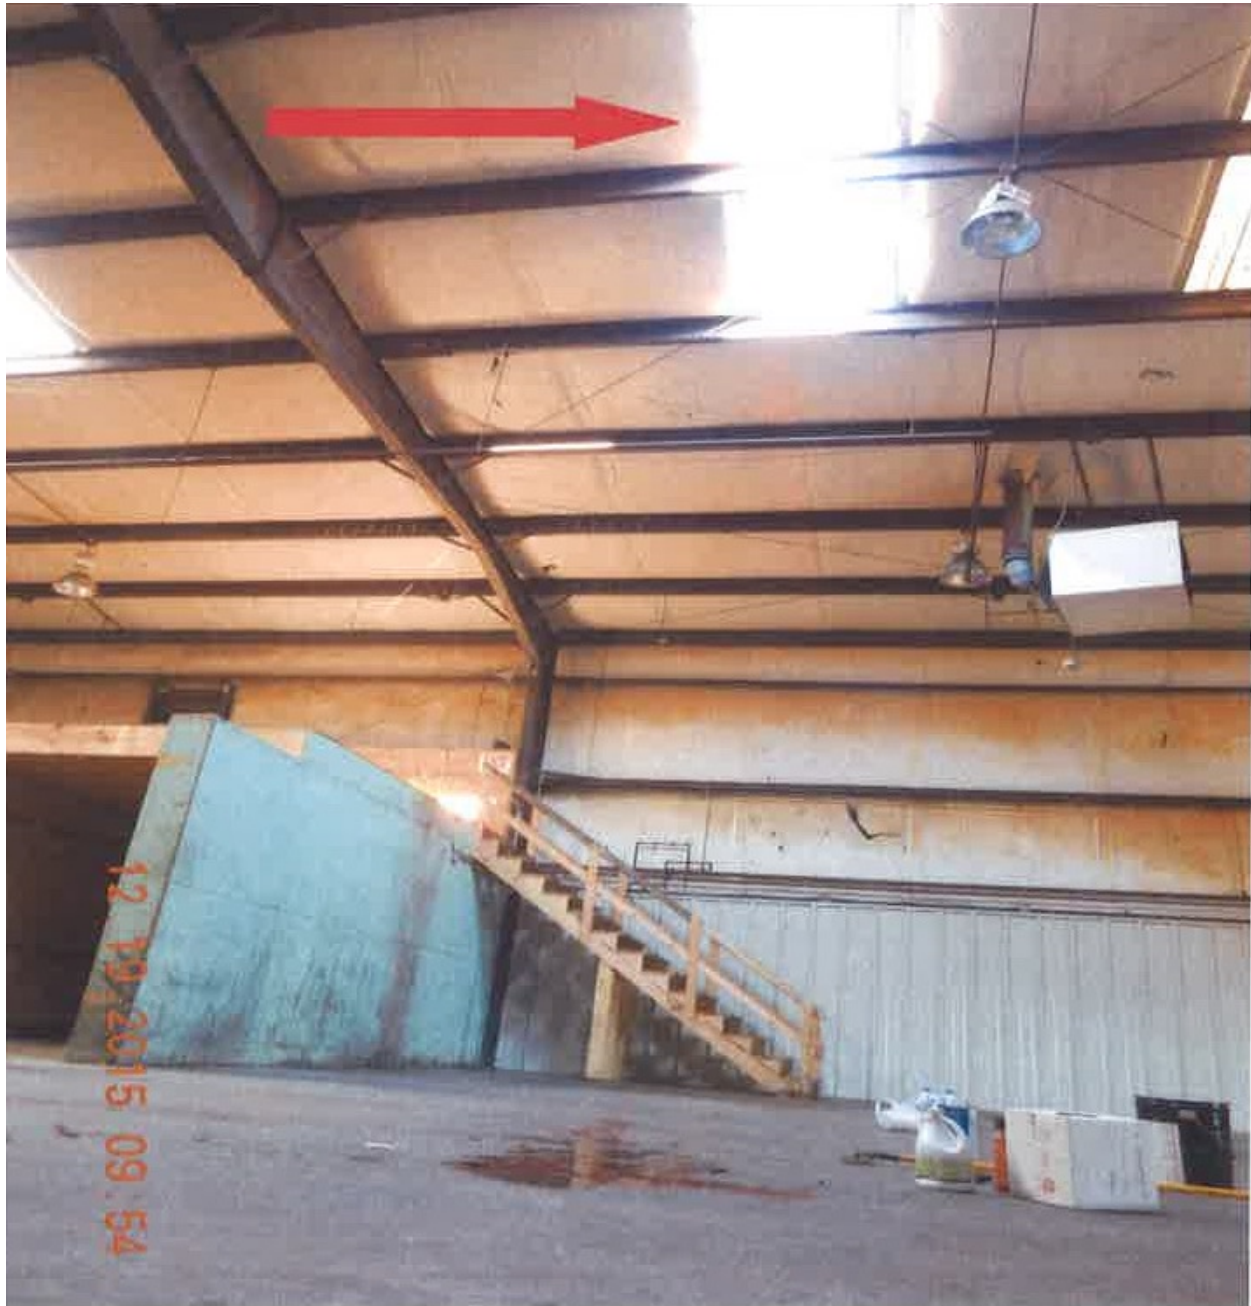
Photo 1 of 2 – Photo of shows the inside of the building which was in process of having its roof replaced. The victim was working near an opening on the roof when he slipped and fell.

29 CFR 1926.501(b)(4)(i)	Each employee on walking/working surfaces shall be protected from falling through holes (including skylights) more than 6 feet (1.8 m) above lower levels, by personal fall arrest systems, covers, or guardrail systems erected around such holes: In that three employees who were assisting in the removal and replacement of metal roofing were not protected from falling through holes in the roof by personal fall arrest systems, hole covers, or guardrails systems. The employees were exposed to fall of 25 feet to the concrete floor below.
--------------------------	--

29 CFR 1926.501(b)(10)	Except as otherwise provided in paragraph (b) of this section, each employee engaged in roofing activities on low-slope roofs, with unprotected sides and edges 6 feet (1.8 m) or more above lower levels were not protected from falling by guardrail systems, safety net systems, personal fall arrest systems, or a combination of warning line system and guardrails system, warning line system and safety net system, or warning line system and personal fall arrest system, or warning line system and safety monitoring system: In that three employees who were assisting in the removal and replacement of metal roofing on a low-sloped roof were not protected from falling off the roof by some form of fall protection. The employees were exposed to falls of 25 feet to the ground below.
------------------------	--

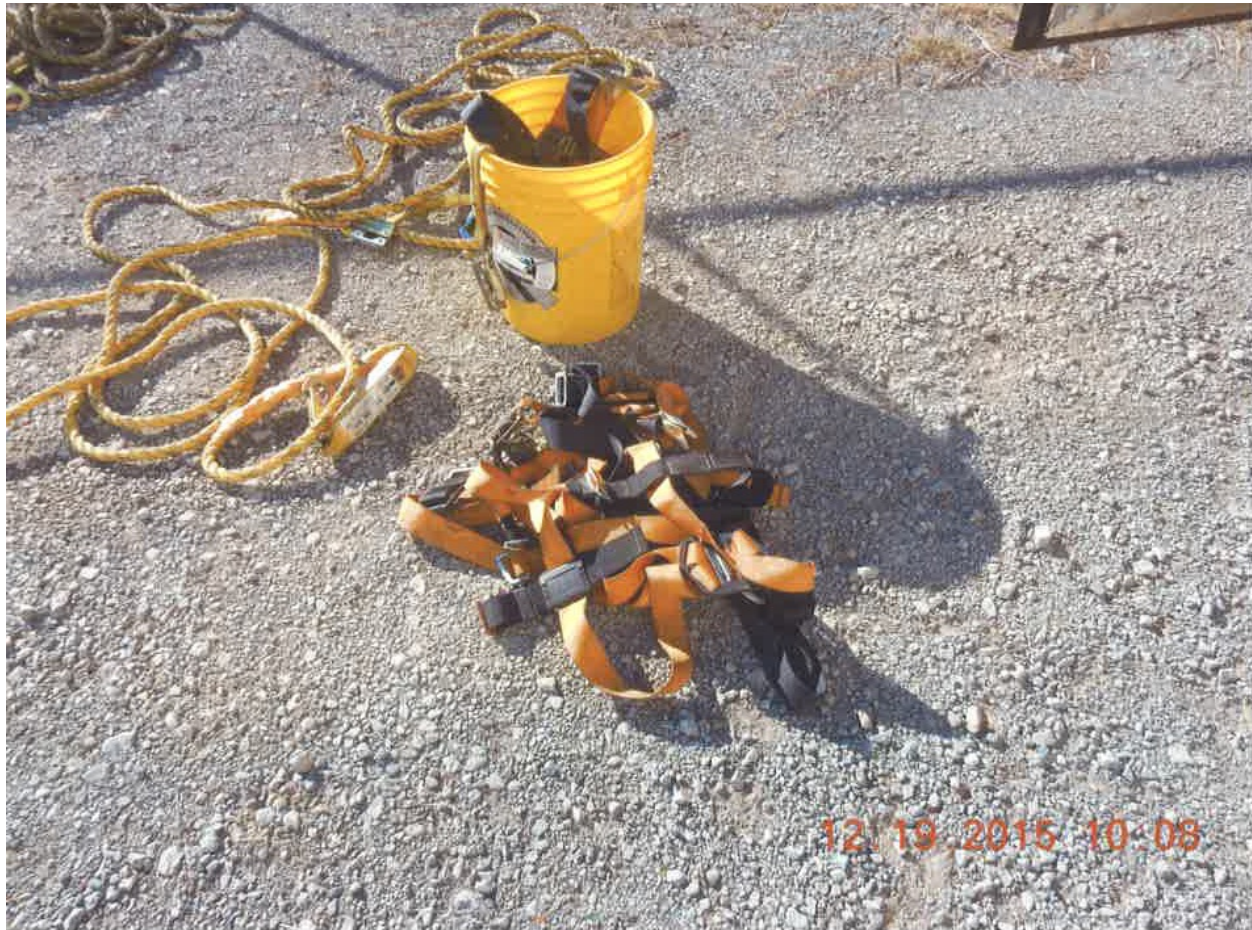
Photo 2 of 2 – Photo shows the fall protection equipment that employees had been wearing but stopped using.
