## **Struck by & crushed by garbage truck - Inspection #1086407**

A **19 year old male employee** was fatally injured when crushed by a garbage truck. The accident occurred during the over-night shift in downtown Nashville while collecting solid waste. The garbage truck was in reverse, backing into an alleyway on Commerce Street, and the victim was riding on the rear passenger side of the truck. While the truck was backing into the alleyway the victim was pinned between the truck and the building when the rear of the garbage truck struck the corner of the building. The victim then fell off the back of the truck. The driver, not seeing the victim, continued to maneuver the garbage truck into the alleyway backing over the victim. The victim's co-worker began yelling at the driver to stop, however the victim was then driven over a second time as the truck pulled forward. The victim had been working in another department of Metro Nashville and this was his first shift working with the sanitation department.

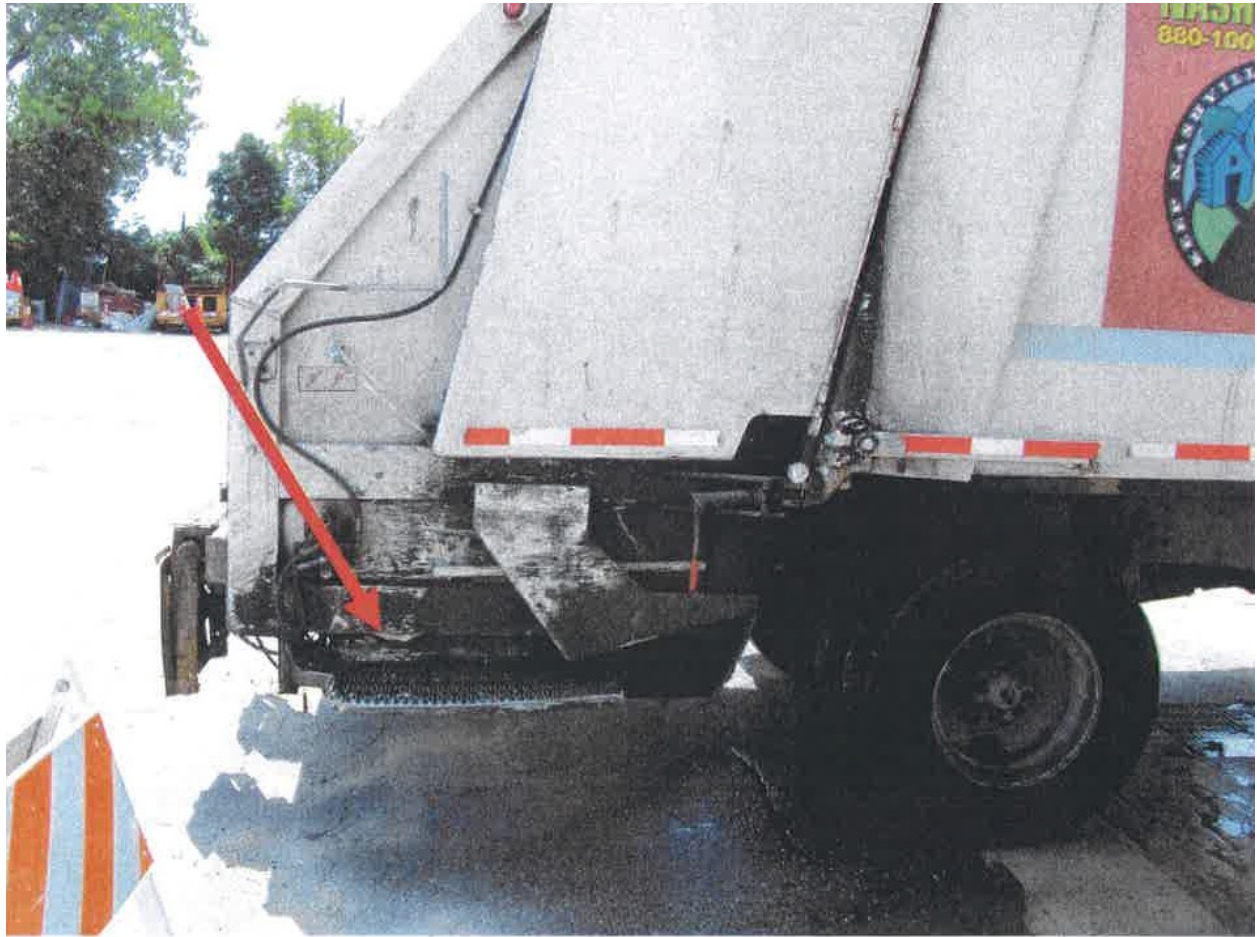
Photo 1 of 2 – This photo shows the approximate location where the victim was standing at the time of the accident.

TCA 50-3-105(1)	Each employer did not furnish to each of its employees conditions of employment and a place of employment free from recognized hazards that are causing or are likely to cause death or serious injury or harm to its employees in that employees were exposed to physical harm such as a crushing hazard: The employer failed to provide employees with the necessary safety training required before operating and working on a sanitation truck and failed to protect employees from the recognized hazards associated with mobile refuse-collection equipment. Among other methods, one feasible and acceptable abatement method is to follow the owner's manual operating instructions or ANSI Z245.1-1992 sections 6.1.a-6.1.1, 6.2.1, and 6.2.4 that set safe operating guidelines an equipment usage which include; a) Providing instruction and training of employees in safe methods of work before assigning them to operate or work around a sanitation truck; and b) Ensuring that no person ride on the steps when the vehicle is backing up.

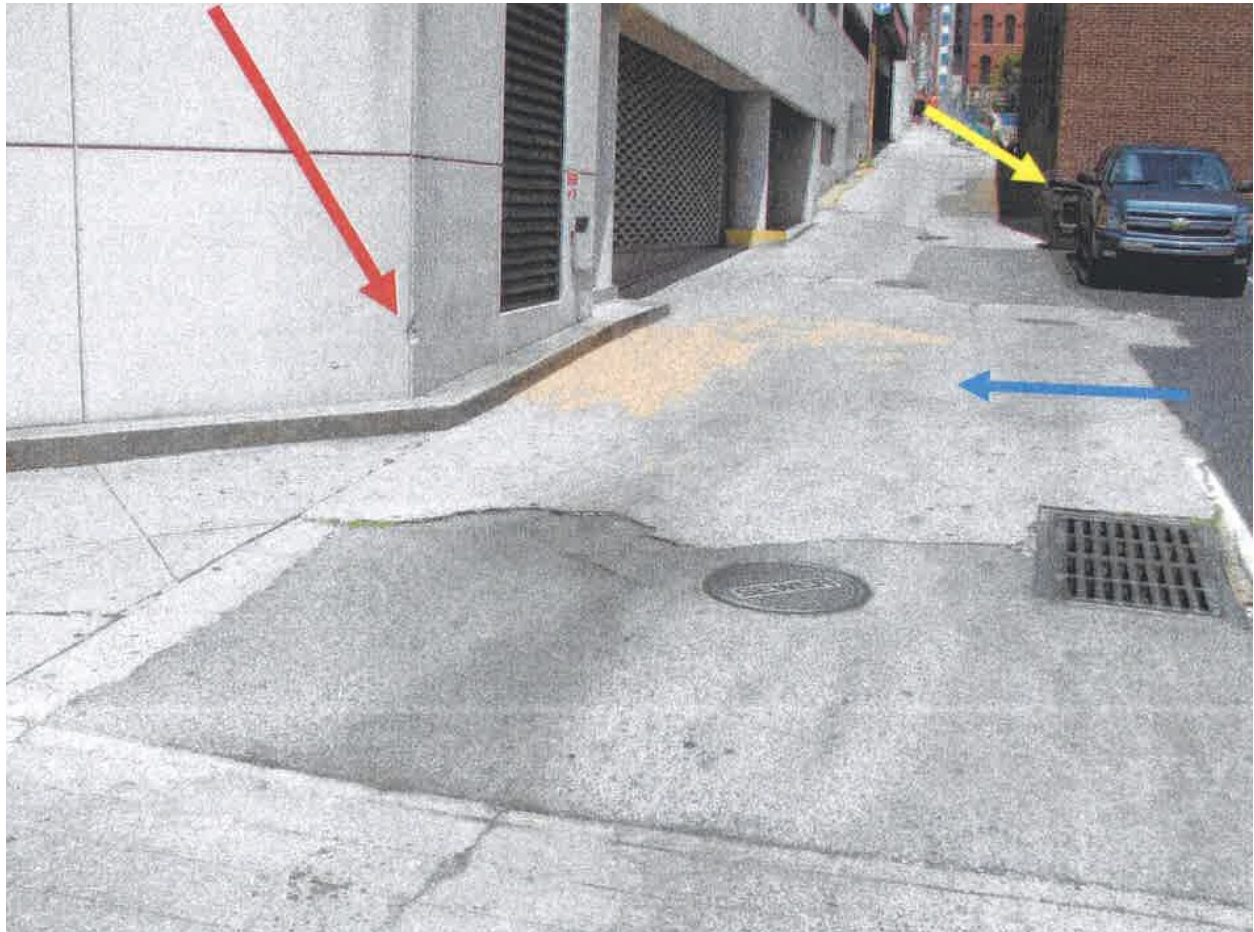
Photo 2 of 2 – The red arrow shows the location of impact with the rear passenger side of the truck and the building. The yellow arrow shows the location of trash cans that were being collected. The blue arrow shows the approximate location where the truck stopped.
