14 Fall through floor opening - Inspection #1234509

A **37 year old male** employee was fatally injured when he fell over 11 feet to the concrete basement of a residential construction. The day prior to the incident, a crane hoisted into place pre-fabricated panels which made up the exterior walls of the home. The victim was part of a six man crew tasked with completing the wood decking and leveling/securing the exterior wall panels located on the main floor. The victim and another employee were adjusting a panel located in the northeast side of the home when the victim stepped backwards into an uncovered floor opening and fell 11 feet 6 inches to the concrete basement below. The floor opening measured 11 feet 11 inches by 3 feet 7 inches and was the future location of a stairwell to the basement. During interviews it was determined that the work on the exterior panels and plywood decking of the residential home progressed so quickly over the past few days that the floor holes were not covered. Employees had been trained on the requirements and use of fall protection devices.

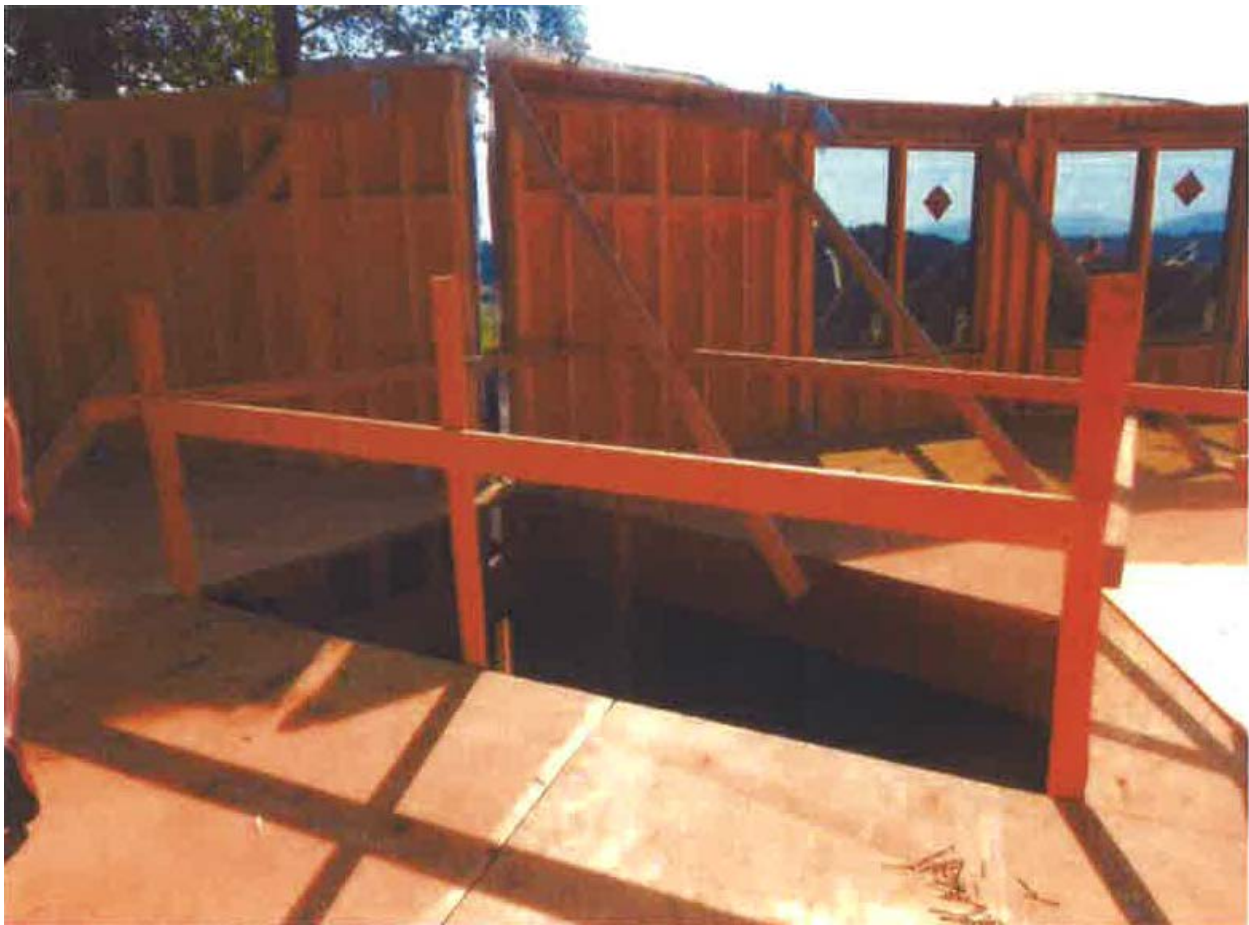
29 CFR 1926.501(b)(4)(i)	<p>Each employee on walking/working surfaces shall be protected from falling through holes (including skylights) more than 6 feet above lower levels, by personal fall arrest systems, covers, or guardrails systems erected around such holes.</p> <p>In that four employees were exposed to an 11 foot 6 inch fall hazard through two unprotected floor openings located in the work area while installing plywood decking and adjusting bracing for the exterior wall panels.</p>
--------------------------	---

Photo 1 of 1 – Floor opening located on the main living area or center section of the home. The guardrail was not in place prior to the incident.
