A **60 year old male** employee was fatally injured when he **fell 14' off a flat roof** while replacing metal flashing on a 13" parapet wall. The company had been on site for approximately 15 days staging material and performing work on multiple wings of the building, such as removing ridge caps from parapet walls. The company had staged materials on the southern portion of the building and had set up a safety line approximately 10' from the perimeter of the roof of the Western most wing of the building to begin removing the old roof. The warning line was used in conjunction with a safety monitor as part of the company's fall protection plan. The company began by removing metal flashing parapet wall caps and installing temporary covers. The covers were in place to protect against moisture from weather while the old roof was removed. The company would replace the temporary cap with a permanent one as the new roof was installed.

11 Fall from elevation (roof)--Inspection #1410206 Ragan Construction

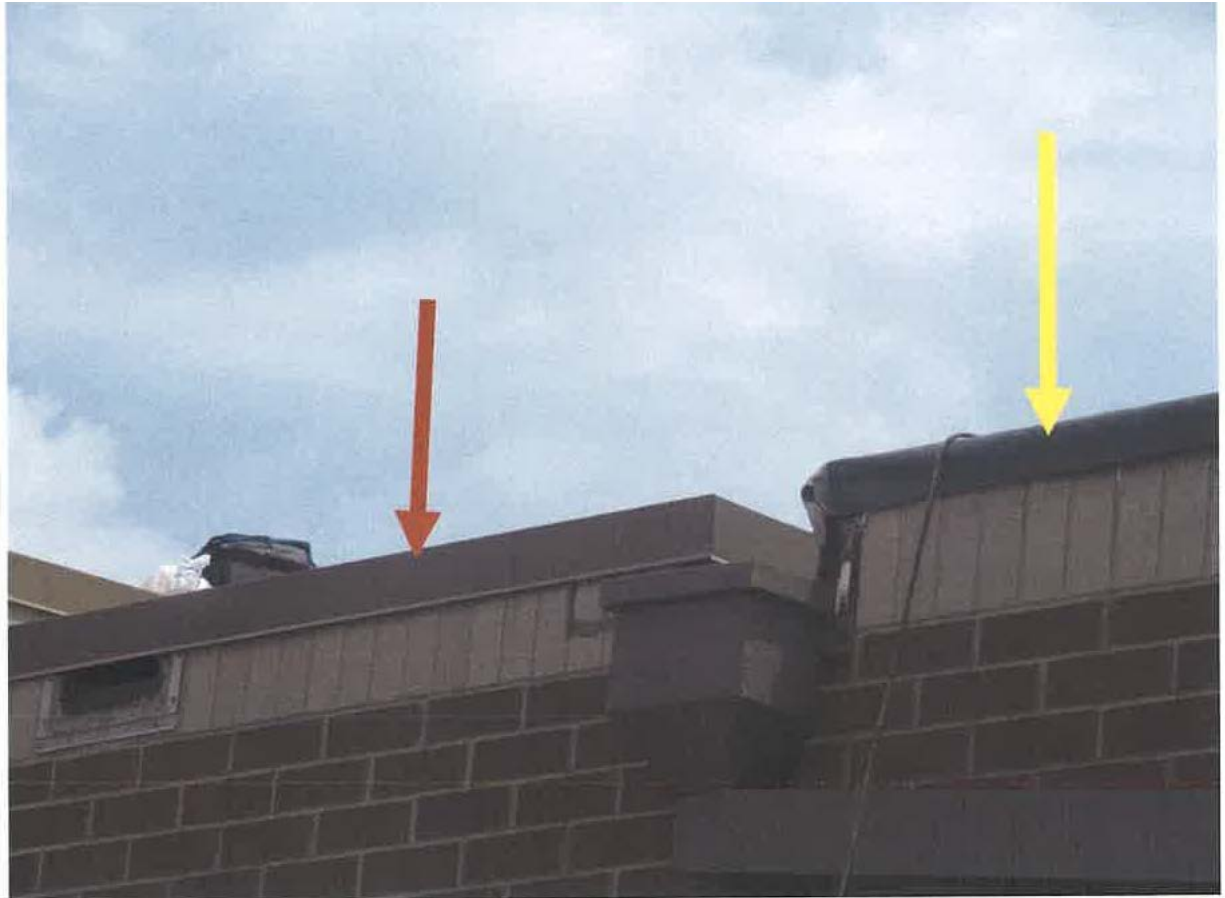
11 Fall from elevation (roof)--Inspection #1410206 Ragan Construction

Red arrow depicts metal flashing parapet wall cap the employee was removing. Yellow arrow depicts the temporary cover the employee was applying with bonding adhesive when he fell.
