A **78 year old male** fell while either ascending or descending the set of stairs at his guard station. There was a mid-rail missing on the guardrail system of the open sided stairs.

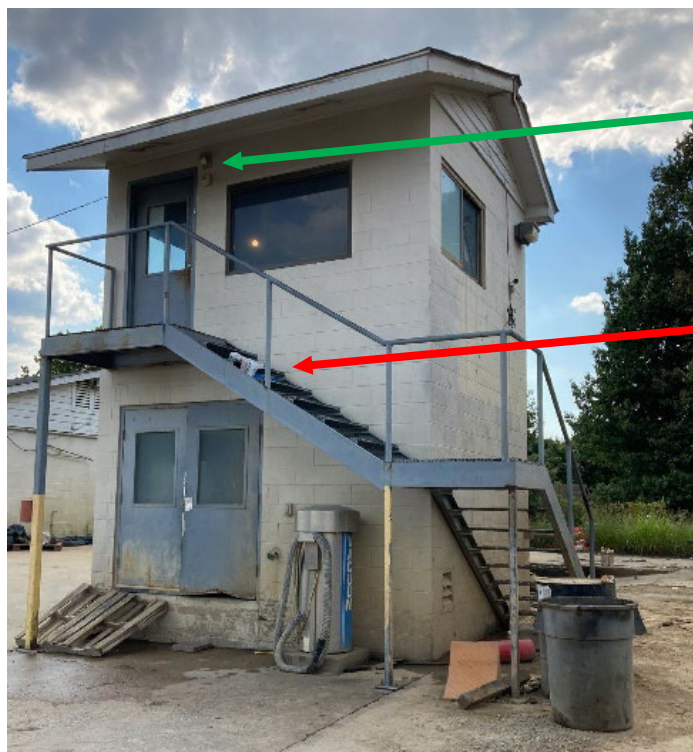
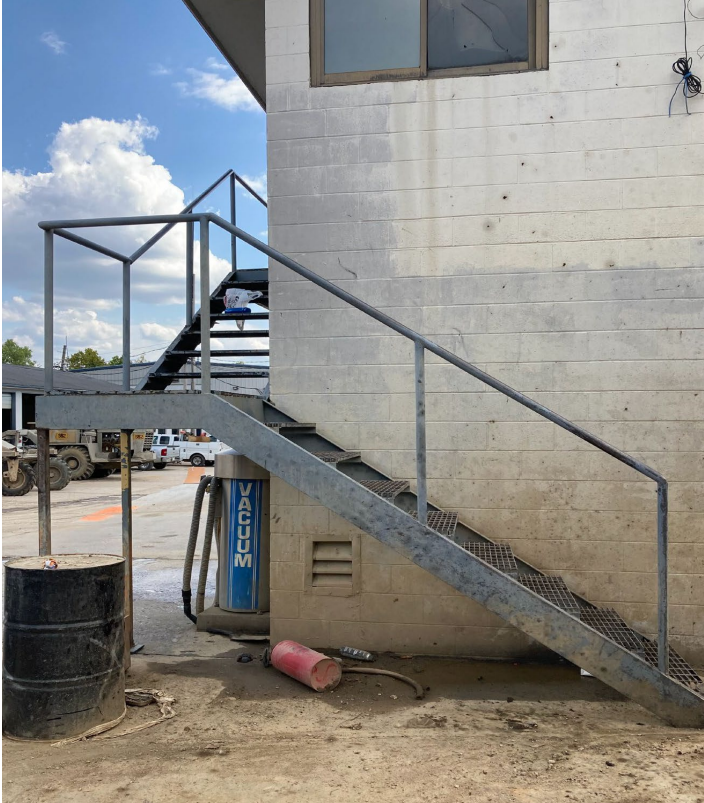
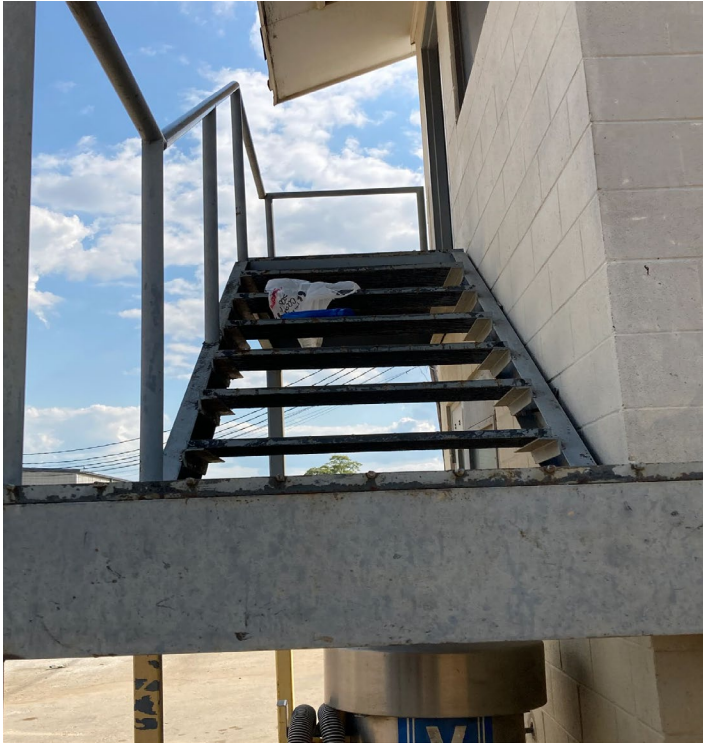
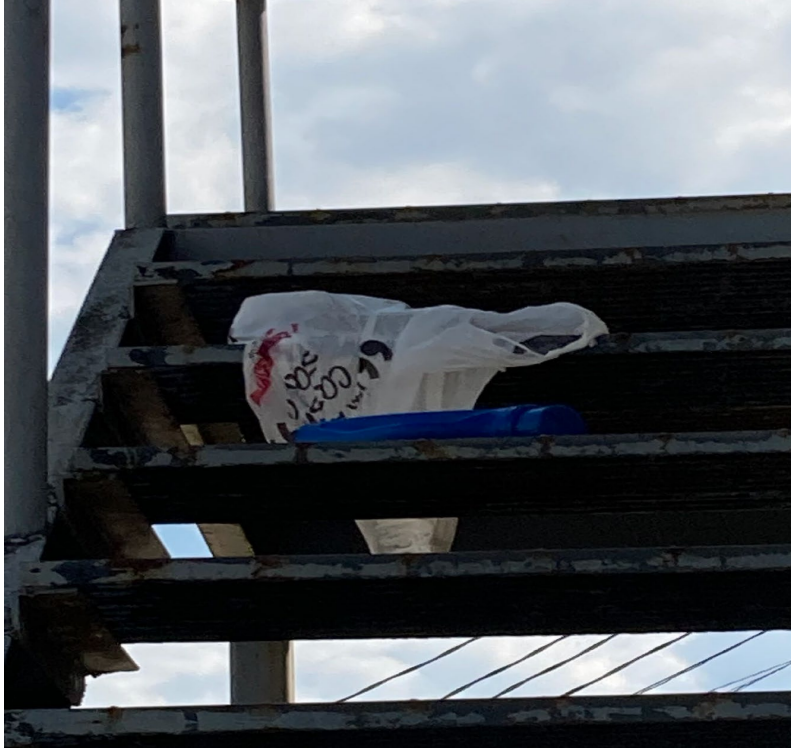
The guard station is a two-story block building with the office on the top level and a storage area below. To access the guard station office area, the employees have to walk up eight steps to the first landing and then six more steps to the next landing outside the guard station office door. It was observed during the onsite inspection that the set of stairs in place and the landings were equipped with only a top rail on the open side. There was no mid rail in place. The top rail was observed to be installed at the proper height. The steps and landings were made of a metal grating and there did not appear to be any damage. Also, the light outside the guard station office door was not functioning. It was determined through an interview with HR Manager for Ferrell Paving, that the same set of steps had been in place for approximately 20 years and there had been no modifications made.

From the top landing to the ground below was 10'3 7/8" and from the 1st landing to the ground was approximately 72 1/2". It was observed that there was a plastic bag with a water bottle and detergent bottle overturned on the 2nd and 3rd step from the top landing.

Through observation of the scene and information obtained, it is reasonable to believe that the victim was ascending or descending the stairs as some of his belongings were observed turned over on the 2nd & 3rd step from the top landing. The lighting over the stairs was not adequate as the light outside the guard station door was not functioning and there was only a lamp in the guard station office shining through the window. Based on the location of the victim, when found, and his belongings scattered on the ground around him, it is reasonable to believe that he fell through the opening left by the missing mid-rail. The victim may have dropped some of his belongings on the steps, reached down to pick them up, lost his balance and fell through the open space or he could have tripped on the metal grating steps, due to the poor lighting, when ascending or descending the stairs, lost his balance and fell through the open space.

**29 CFR 1910.29(b)(2)(i):** Mid-rails were not installed at a height midway between the top edge of the guiderail system and the walking-working surface:

In that the set of stairs at the guard station, located at Ferrell Paving Inc., 2174 East Person Ave., Memphis, TN was not equipped with a midrail.

**29 CFR 1910.37(b)(1):** Each exit route was not adequately lighted so that an employee with normal vision can see along the exit route.

In that the light outside the guard station office, located at Ferrell Paving Inc, 2174 East Person Ave., Memphis, TN, to exit via the stairs, was not operable.
